**2020 SSES PROGRAM CITY
OF BLOOMINGTON, IL
FINAL REPORT**

MAY 2021

PROJECT NO: 11-3577-01

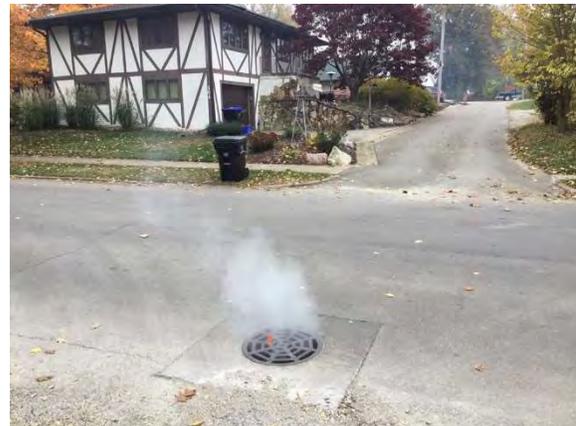
Figure 2 –Smoking Manhole

Heavy smoke from a storm inlet or manhole can indicate a severely leaking cross-connection, a sanitary sewer overflow, or a direct connection to the sanitary sewer. A direct connection is when the storm sewer or storm structure is directly piped into the sanitary sewer. See Figure 2.

While cross-connections can contribute large amounts of inflow, their magnitude and repair location are not known from smoke testing alone. Therefore, RJN Group followed up with dye flooding inspections at these locations to pinpoint and quantify the amount of water that is leaking from each cross-connection. The nature of each cross-connection defect is best evaluated when dyed water flooding is performed in conjunction with Closed Captioned Televising (CCTV). The results of the dye flood inspections and recommendations will be documented in a separate report.

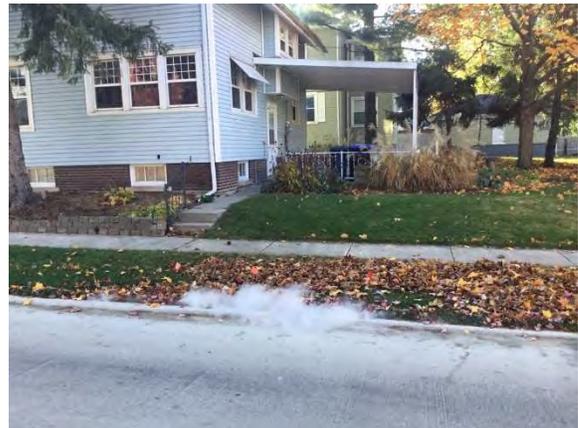
Figure 3 – Sanitary Mainline

The second most significant public defect observed through field investigations were five (5) sanitary mainline smoke defects. The smoke can be a sign of a structural defect, such as a pipe fracture or collapse. These pipes are recommended to be televised. See Figure 3.

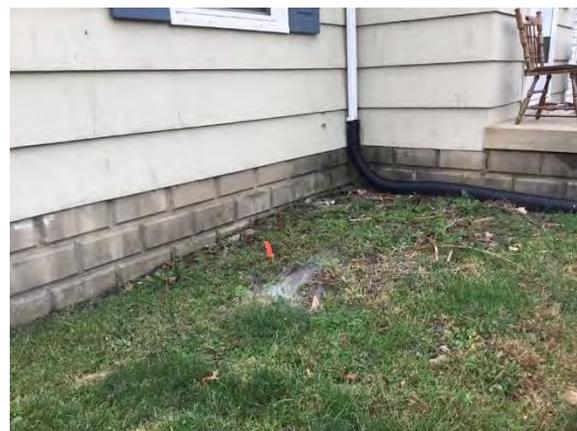
Figure 4 –Lateral

The largest contributor of I/I in the private sector, that needs additional investigation, were laterals. The forty-four (44) lateral defects identified during smoke testing are recommended for repair under the category of Long-Term Program. The laterals are recommended for televising, and as follow-up, potentially T-lining. Televising of laterals should be completed prior to rehabilitation of any laterals. This will lead to a more comprehensive approach to a long-term private sector rehabilitation program. See Figure 4.

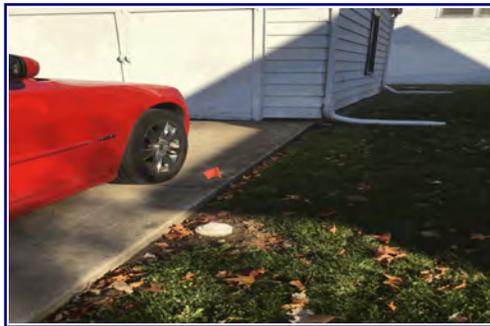
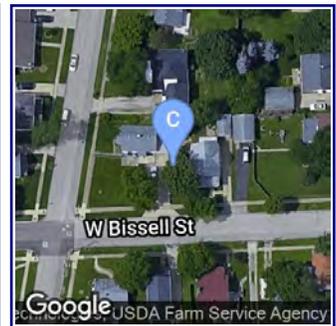
Cleanout, Defective

Basin:
Segment (US : DS): **43510:43500**
Intensity: **Low**
Drainage Area (SF): **50**
Surface: **Unpaved**
Comments:

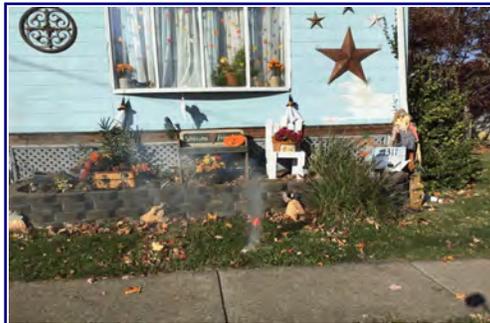
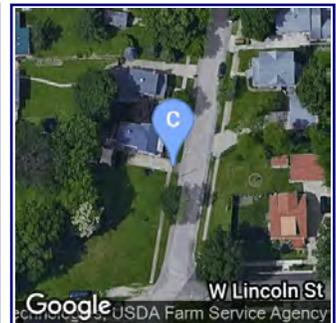
Cleanout, Missing/Broken Cap

Basin:
Segment (US : DS): **44340:43500**
Intensity: **Medium**
Drainage Area (SF): **100**
Surface: **Unpaved**
Comments:

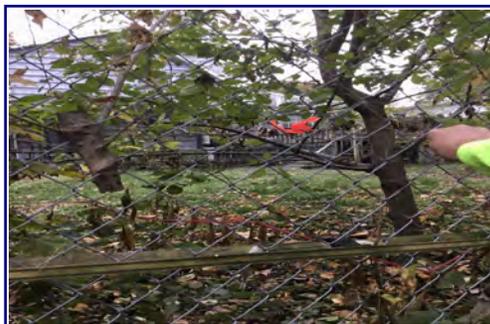
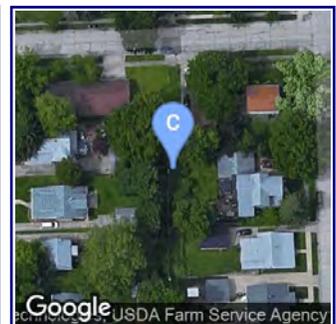
Cleanout, Missing/Broken Cap

Basin:
Segment (US : DS): **43960:43440**
Intensity: **Medium**
Drainage Area (SF): **200**
Surface: **Unpaved**
Comments: *Defect is located under deck in enclosed yard.*
