**2020 SSES PROGRAM CITY
OF BLOOMINGTON, IL
FINAL REPORT**

MAY 2021

PROJECT NO: 11-3577-01

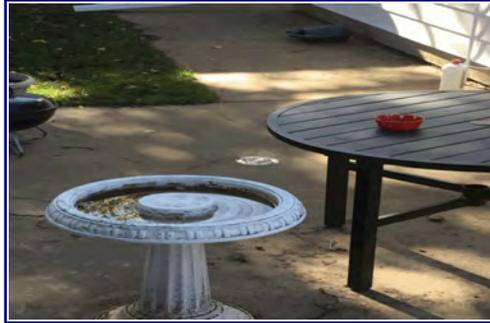
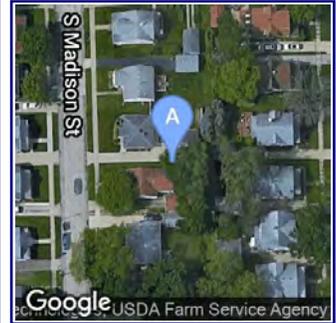
Address: 1308 S Madison St

Basin:
Segment (US : DS): **43520:43510**
Intensity: **High**
Drainage Area (SF): **100**
Surface: **Paved**
Comments:

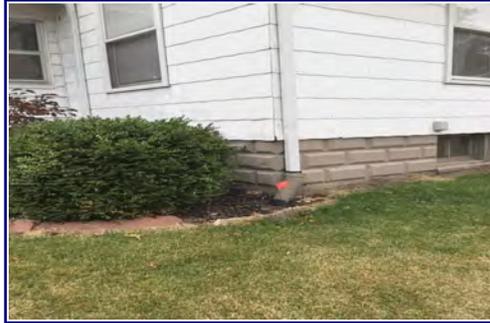
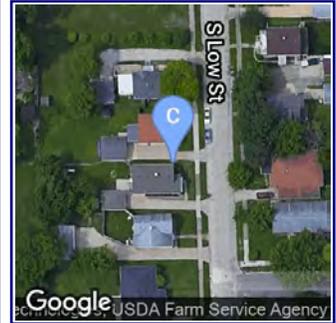
Address: 1227 Low St

Basin:
Segment (US : DS): **44090:43450**
Intensity: **High**
Drainage Area (SF): **120**
Surface: **Unpaved**
Comments: *This defect is located near a gutter*

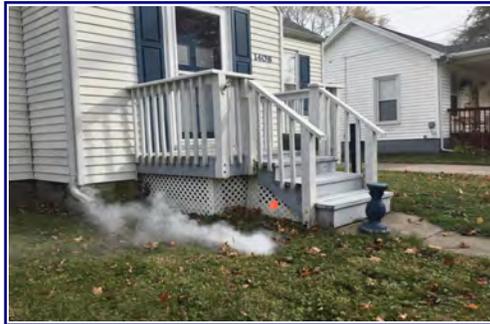
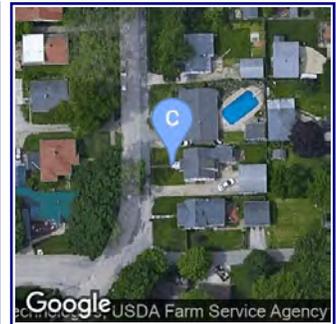
Address: 1408 Low St

Cleanout, Missing/Broken Cap

Basin:
Segment (US : DS): **44100:44090**
Intensity: **High**
Drainage Area (SF): **200**
Surface: **Unpaved**
Comments:

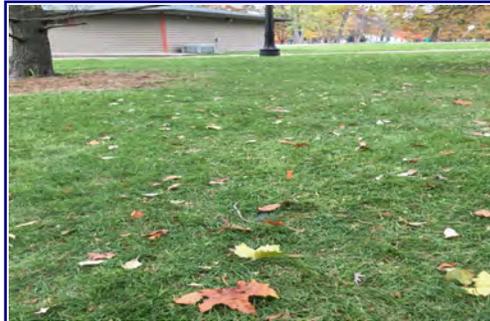
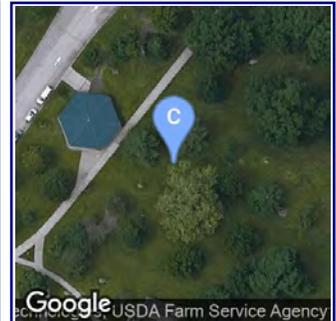
Address: 1122 Morris

Cleanout, Missing/Broken Cap

Basin:
Segment (US : DS): **43410:43408**
Intensity: **Low**
Drainage Area (SF): **10**
Surface: **Unpaved**
Comments:

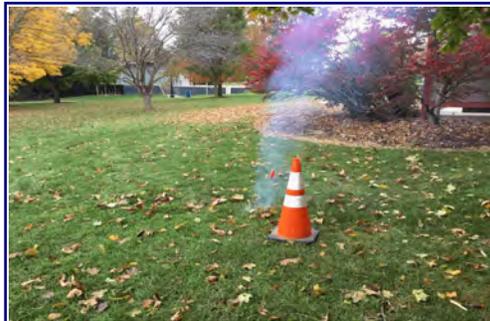
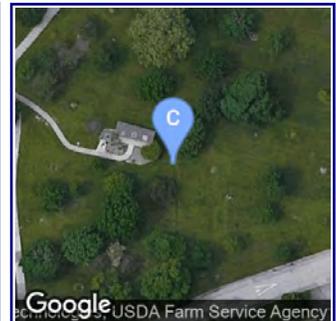
Address: 1122 Morris

Cleanout, Missing/Broken Cap

Basin:
Segment (US : DS): **43410:43408**
Intensity: **High**
Drainage Area (SF): **300**
Surface: **Unpaved**
Comments:

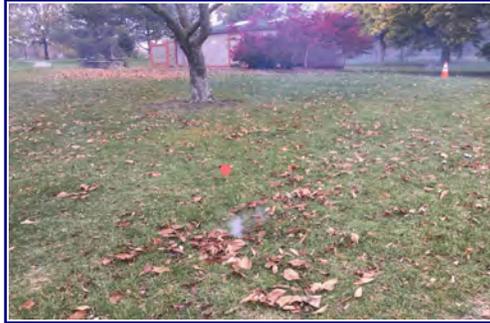
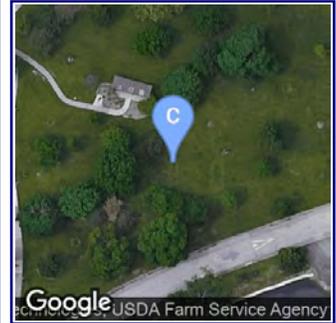
Address: 1122 Morris

Basin:
Segment (US : DS): **43410:43408**
Intensity: **Medium**
Drainage Area (SF): **500**
Surface: **Unpaved**
Comments:

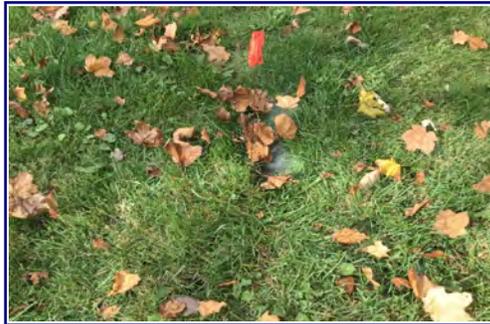
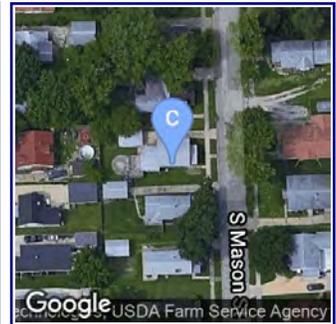
Address: 1211 S mason st

Cleanout, Missing/Broken Cap

Basin:
Segment (US : DS): **44180:44170**
Intensity: **Low**
Drainage Area (SF): **300**
Surface: **Unpaved**
Comments:

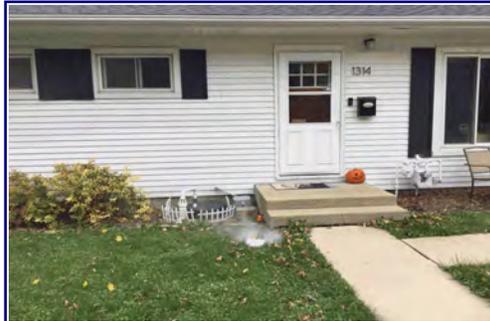
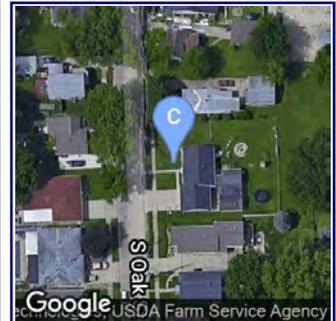
Address: 1314 S oak st

Cleanout, Missing/Broken Cap

Basin:
Segment (US : DS): **44290:43490**
Intensity: **Medium**
Drainage Area (SF): **200**
Surface: **Unpaved**
Comments:

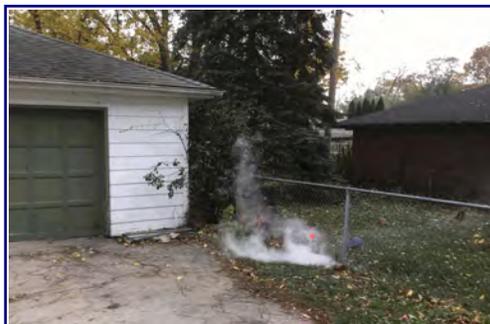
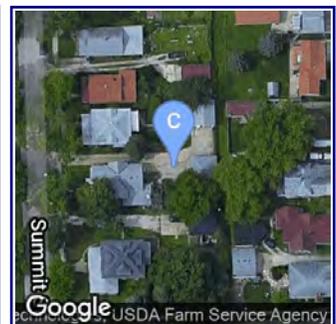
Address: 918 Summit St

Cleanout, Missing/Broken Cap

Basin:
Segment (US : DS): **UNKNOWN:43960**
Intensity: **High**
Drainage Area (SF): **300**
Surface: **Unpaved**
Comments:

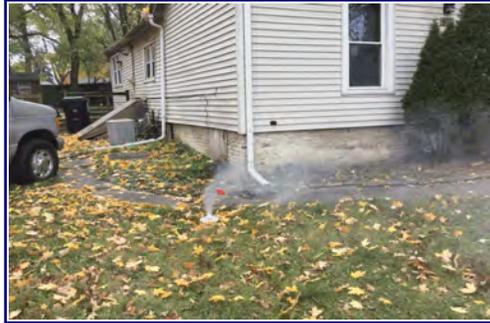
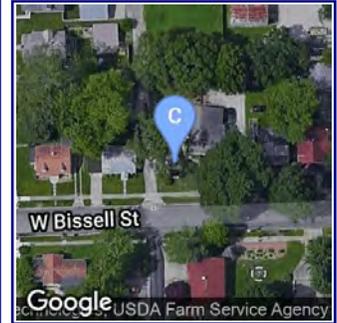
Address: 405 W Bissell St

Basin:
Segment (US : DS): **43500:43490**
Intensity: **Medium**
Drainage Area (SF): **200**
Surface: **Unpaved**
Comments:

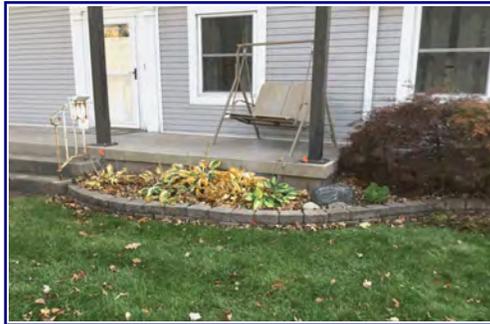
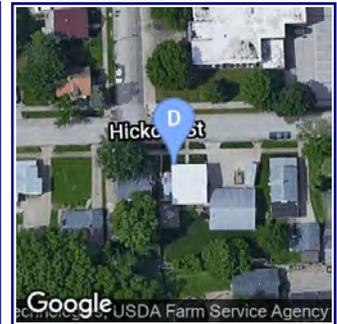
Address: 408 Hickory St

Downspout U G (Multi Defects)

Basin:
Segment (US : DS): **44280:44270**
Intensity: **Low**
Drainage Area (SF): **100**
Surface: **Unpaved**
Comments:

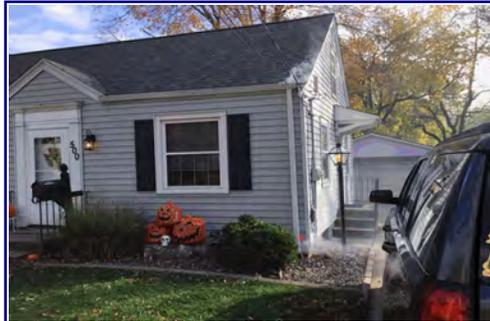
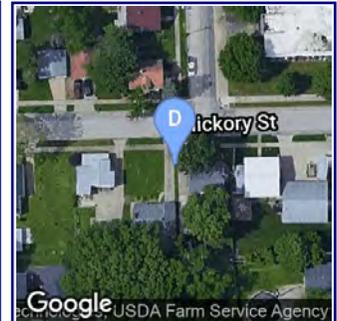
Address: 500 Hickory st

Downspout U G (Multi Defects)

Basin:
Segment (US : DS): **44270:44260**
Intensity: **High**
Drainage Area (SF): **500**
Surface: **Unpaved**
Comments:

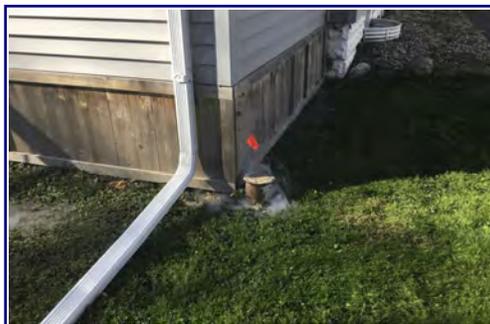
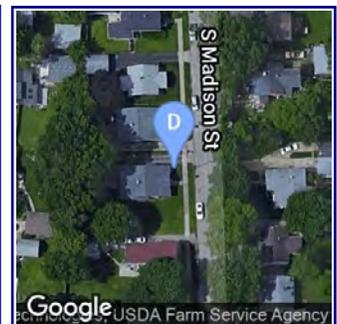
Address: 1113 S Madison St

Downspout U G (Multi Defects)

Basin:
Segment (US : DS): **44360:43510**
Intensity: **Medium**
Drainage Area (SF): **100**
Surface: **Unpaved**
Comments:

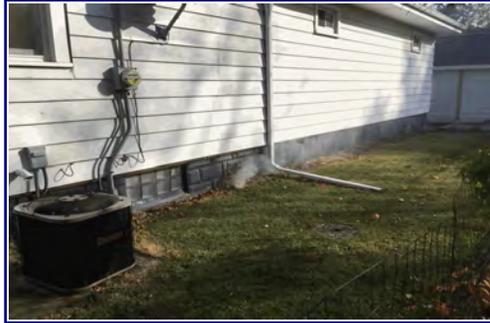
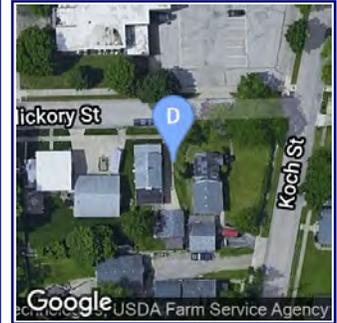
Address: 402 Hickory St

Basin:
Segment (US : DS): **44280:44270**
Intensity: **Medium**
Drainage Area (SF): **200**
Surface: **Unpaved**
Comments:

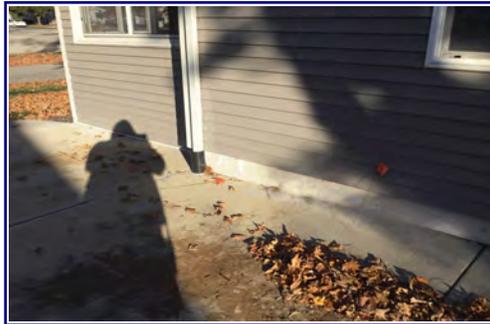
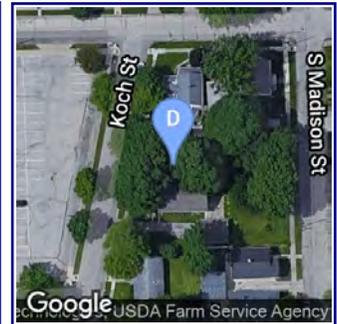
Address: 1204 Koch St

Downspout, Disconnected

Basin:
Segment (US : DS): **44320:44310**
Intensity: **Medium**
Drainage Area (SF): **200**
Surface: **Paved**
Comments:

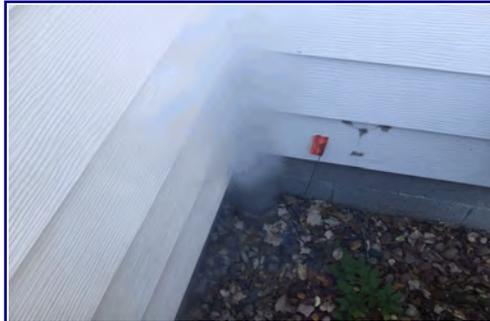
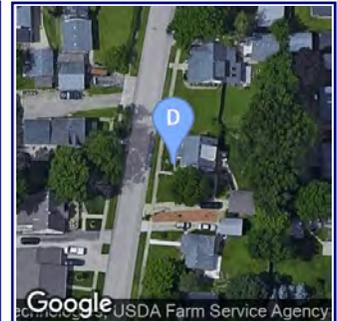
Address: 1214 Koch st

Downspout, Disconnected

Basin:
Segment (US : DS): **44310:43500**
Intensity: **High**
Drainage Area (SF): **100**
Surface: **Unpaved**
Comments:

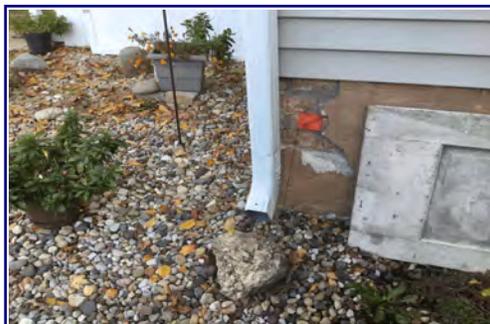
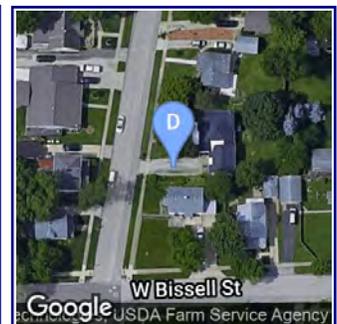
Address: 1218 Koch St

Downspout, Disconnected

Basin:
Segment (US : DS): **44310:43500**
Intensity: **Low**
Drainage Area (SF): **100**
Surface: **Paved**
Comments:

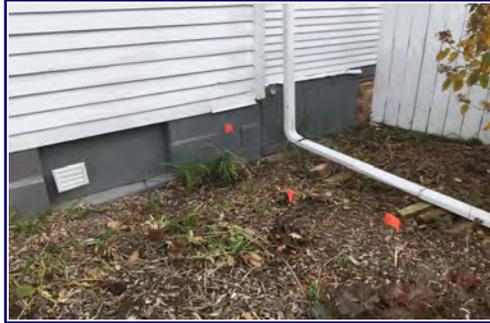
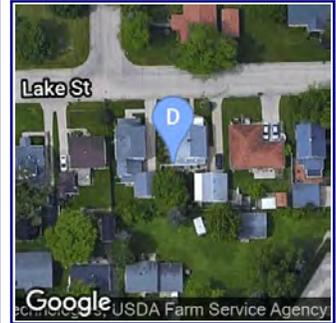
Address: 108 Lake st

Basin:
Segment (US : DS): **44120:44110**
Intensity: **Medium**
Drainage Area (SF): **200**
Surface: **Unpaved**
Comments:

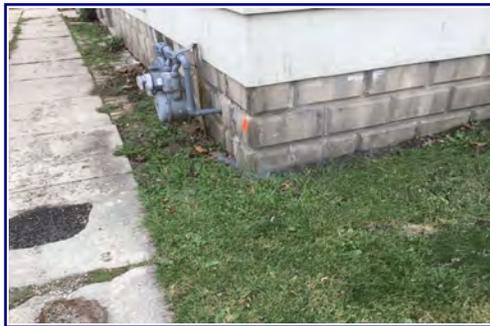
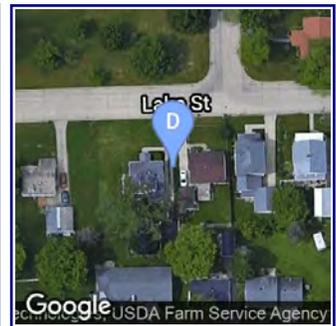
Address: 204 Lake st

Downspout, Disconnected

Basin:
Segment (US : DS): **44120:44110**
Intensity: **Medium**
Drainage Area (SF): **200**
Surface: **Unpaved**
Comments:

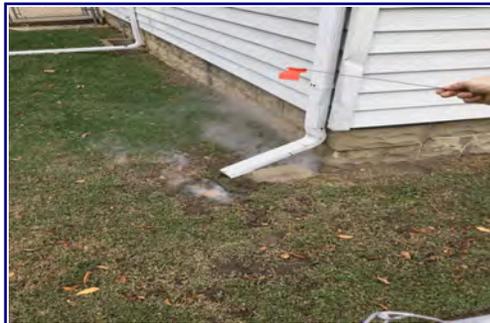
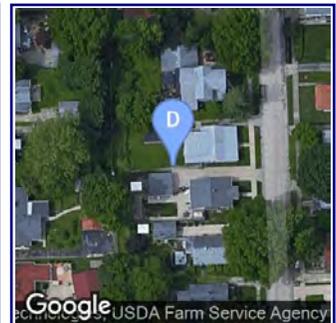
Address: 1107 Low St

Downspout, Disconnected

Basin:
Segment (US : DS): **43960:43440**
Intensity: **Medium**
Drainage Area (SF): **200**
Surface: **Paved**
Comments:

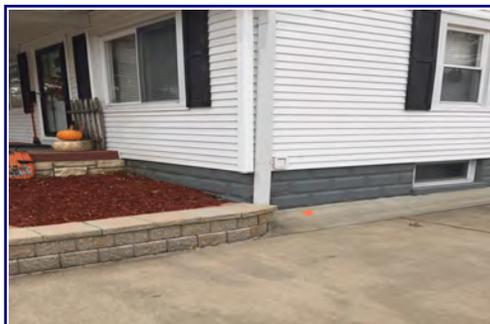
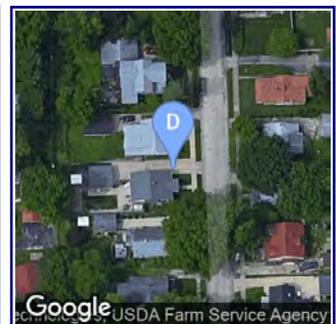
Address: 1109 Low St

Downspout, Disconnected

Basin:
Segment (US : DS): **43960:43440**
Intensity: **Low**
Drainage Area (SF): **100**
Surface: **Unpaved**
Comments:

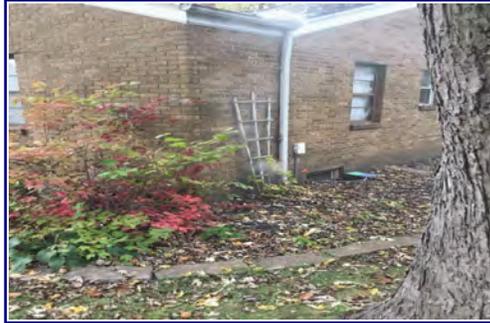
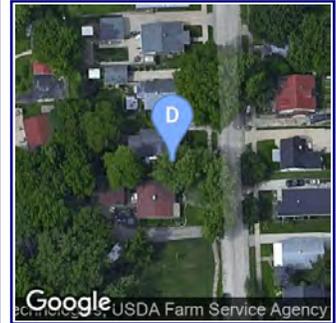
Address: 1115 Low St

Basin:
Segment (US : DS): **43960:43440**
Intensity: **High**
Drainage Area (SF): **200**
Surface: **Unpaved**
Comments:

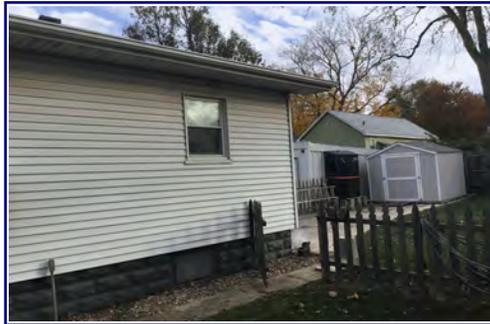
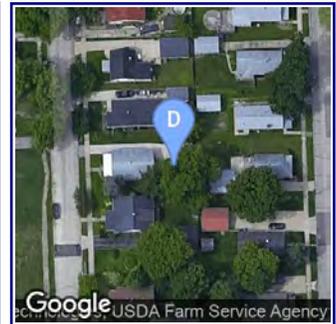
Address: 1118 Low st

Downspout, Disconnected

Basin:
Segment (US : DS): **UNKNOWN:43460**
Intensity: **Medium**
Drainage Area (SF): **100**
Surface: **Unpaved**
Comments:

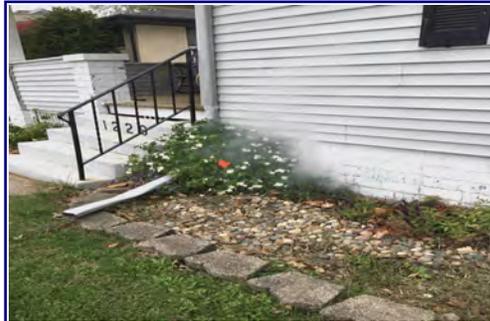
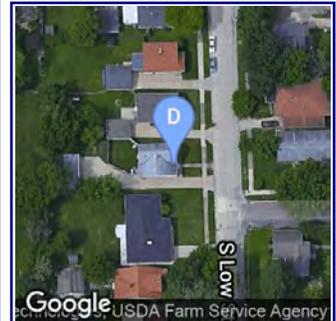
Address: 1229 Low St

Downspout, Disconnected

Basin:
Segment (US : DS): **44090:43450**
Intensity: **High**
Drainage Area (SF): **100**
Surface: **Paved**
Comments:

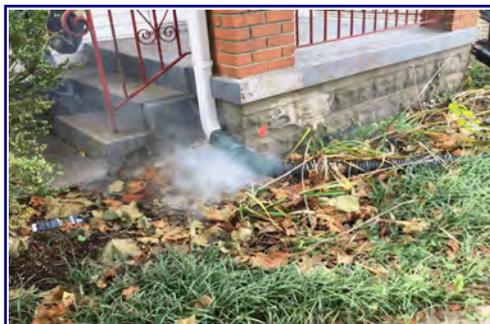
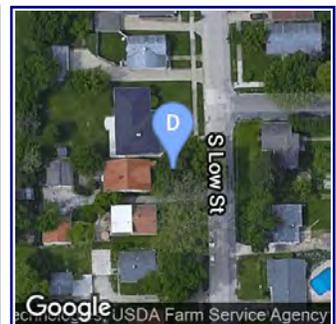
Address: 1403 Low St

Downspout, Disconnected

Basin:
Segment (US : DS): **44100:44090**
Intensity: **High**
Drainage Area (SF): **200**
Surface: **Unpaved**
Comments:

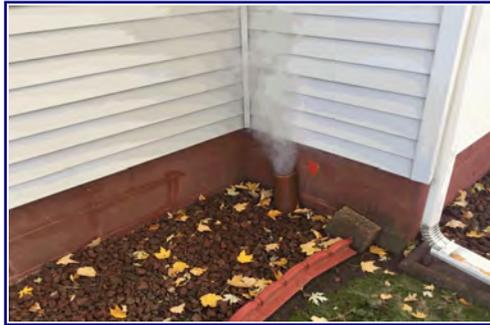
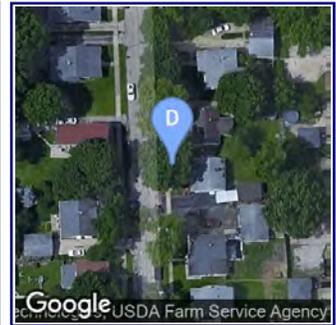
Address: 1210 S madison st

Basin:
Segment (US : DS): **44360:44510**
Intensity: **High**
Drainage Area (SF): **300**
Surface: **Unpaved**
Comments:

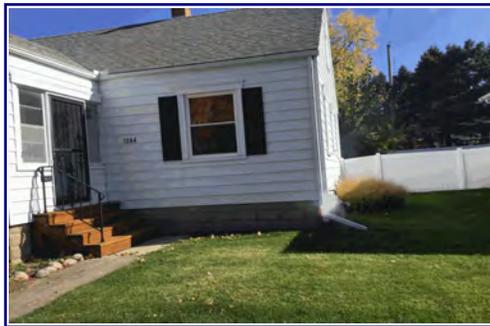
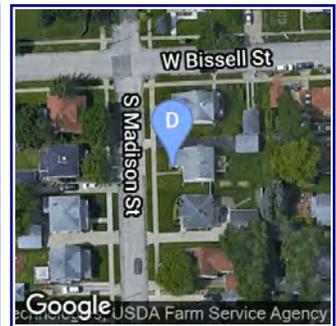
Address: 1304 S madison st

Downspout, Disconnected

Basin:
Segment (US : DS): **43510 :43520**
Intensity: **Medium**
Drainage Area (SF): **200**
Surface: **Unpaved**
Comments:

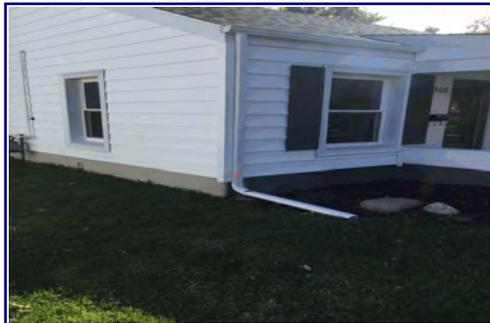
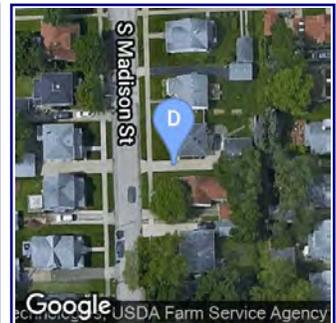
Address: 1308 S Madison St

Downspout, Disconnected

Basin:
Segment (US : DS): **43520:43510**
Intensity: **Medium**
Drainage Area (SF): **200**
Surface: **Unpaved**
Comments:

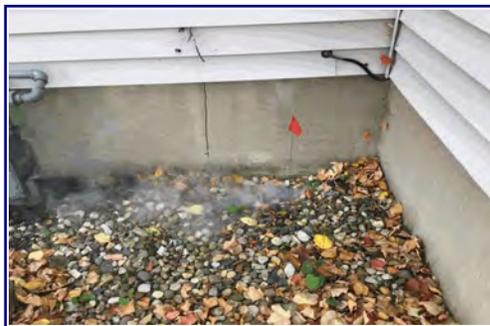
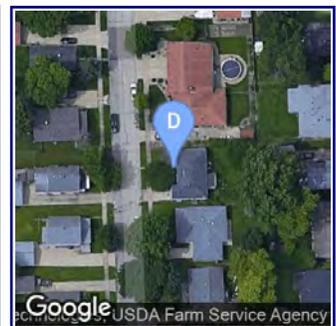
Address: 1224 S mason st

Downspout, Disconnected

Basin:
Segment (US : DS): **44170:43470**
Intensity: **Medium**
Drainage Area (SF): **200**
Surface: **Unpaved**
Comments:

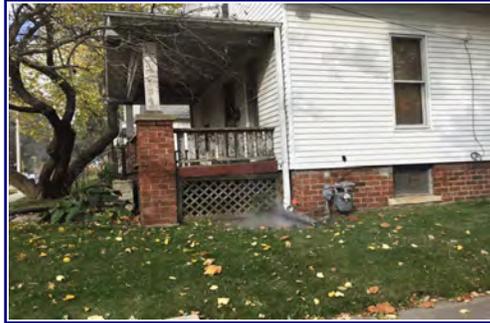
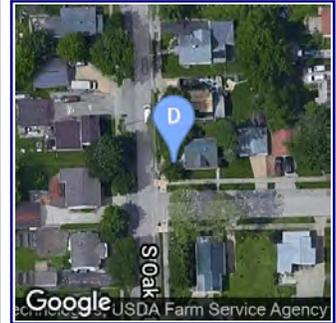
Address: 1114 S oak st

Basin:
Segment (US : DS): **44390:44260**
Intensity: **Medium**
Drainage Area (SF): **200**
Surface: **Unpaved**
Comments:

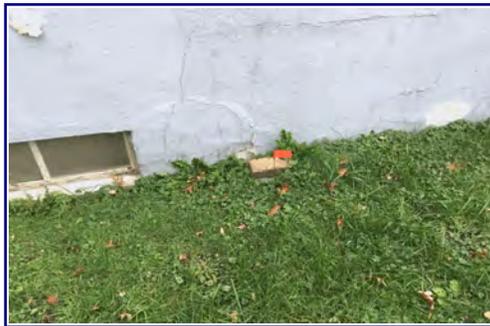
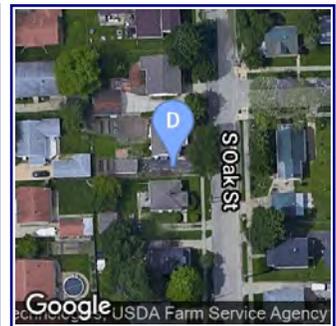
Address: 1203 S oak st

Basin:
Segment (US : DS): **44260:44250**
Intensity: **Low**
Drainage Area (SF): **100**
Surface: **Unpaved**
Comments:

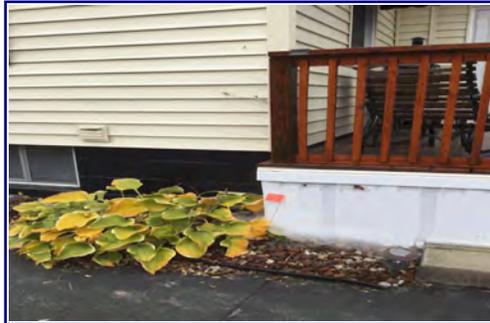
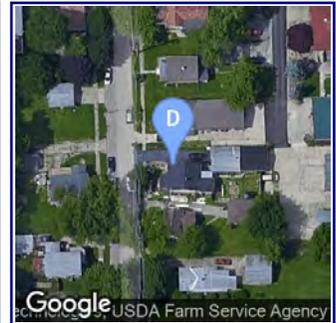
Address: 1308 S Oak St

Downspout, Disconnected

Basin:
Segment (US : DS): **44290:43490**
Intensity: **High**
Drainage Area (SF): **200**
Surface: **Paved**
Comments:

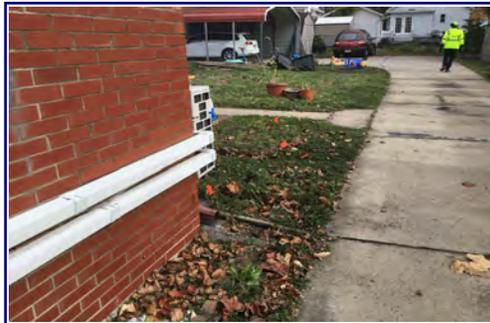
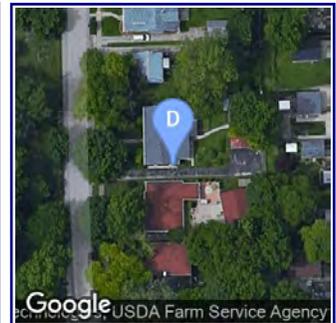
Address: 1010 Summit st

Downspout, Disconnected

Basin:
Segment (US : DS): **43900:43420**
Intensity: **Medium**
Drainage Area (SF): **300**
Surface: **Unpaved**
Comments:

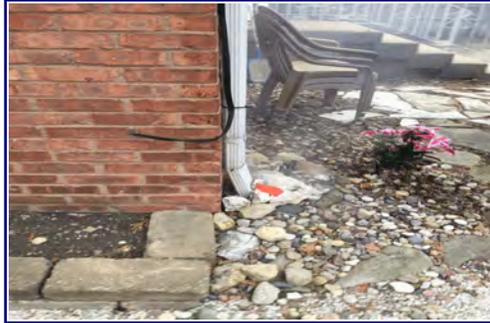
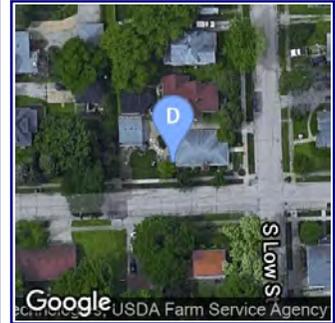
Address: 1009 W miller st

Basin:
Segment (US : DS): **43970:43960**
Intensity: **Medium**
Drainage Area (SF): **1,000**
Surface: **Paved**
Comments:

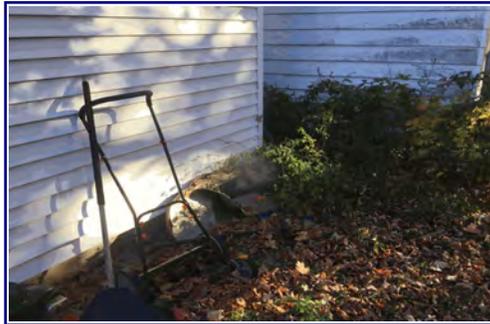
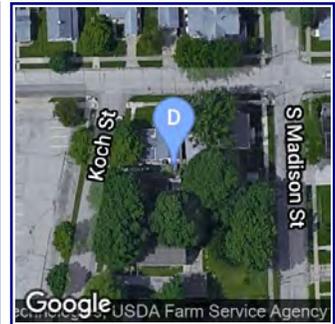
Address: 304 W Miller St

Downspout, Disconnected

Basin:
Segment (US : DS): **44320:44310**
Intensity: **Medium**
Drainage Area (SF): **200**
Surface: **Unpaved**
Comments:

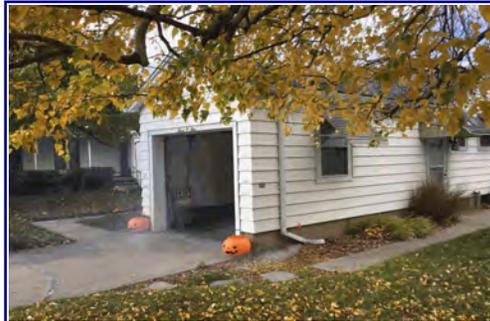
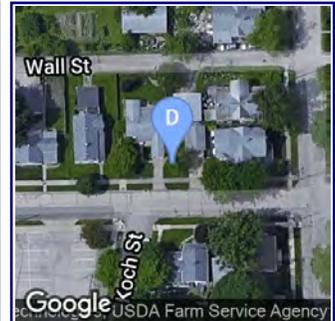
Address: 305 W miller st

Downspout, Disconnected

Basin:
Segment (US : DS): **44320:63705**
Intensity: **Medium**
Drainage Area (SF): **300**
Surface: **Unpaved**
Comments: *Downspout is covered with a ceramic flower pot bottom.*

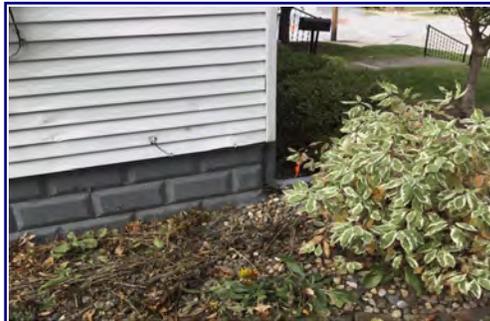
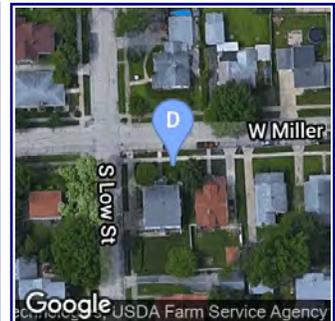
Address: 608 W miller st

Downspout, Disconnected

Basin:
Segment (US : DS): **43980:43970**
Intensity: **Low**
Drainage Area (SF): **200**
Surface: **Unpaved**
Comments:

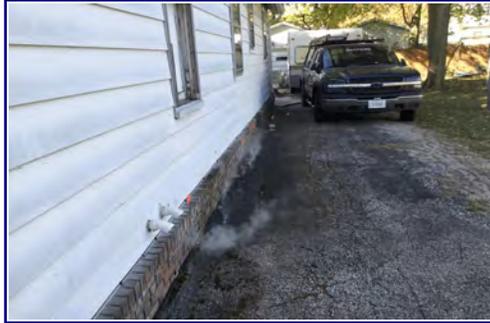
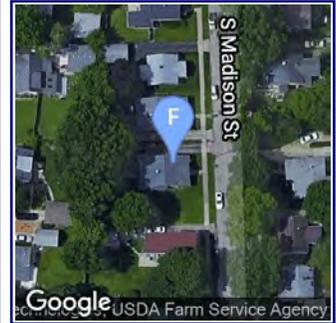
Address: 1209 S madison st

Foundation Drain

Basin:
Segment (US : DS): **44360:44510**
Intensity: **Medium**
Drainage Area (SF): **1,000**
Surface: **Paved**
Comments:

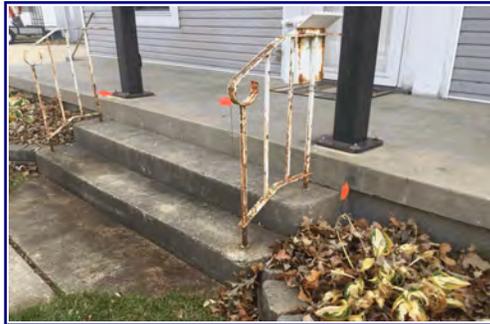
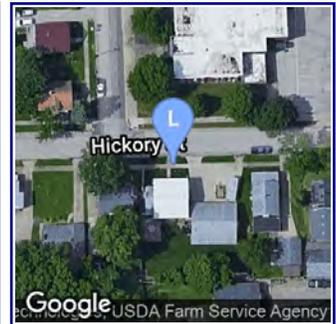
Address: 408 Hickory St

Lateral

Basin:
Segment (US : DS): **44280:44270**
Intensity: **Medium**
Drainage Area (SF): **200**
Surface: **Paved**
Comments:

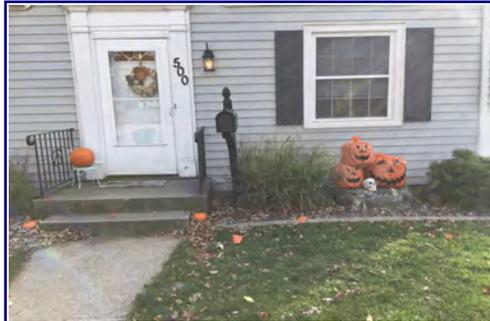
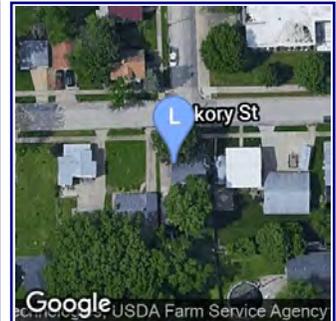
Address: 500 Hickory st

Lateral

Basin:
Segment (US : DS): **44270:44260**
Intensity: **Low**
Drainage Area (SF): **200**
Surface: **Unpaved**
Comments:

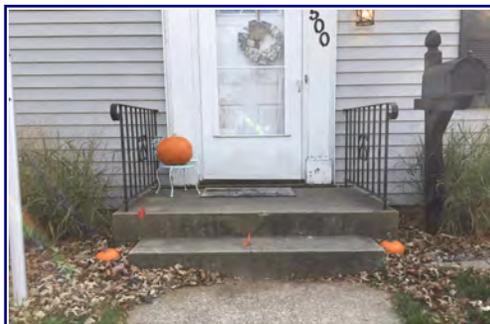
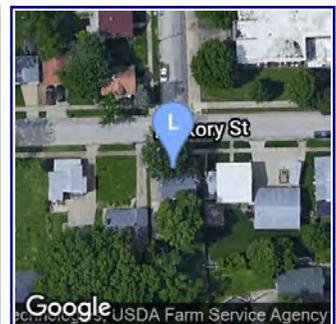
Address: 500 Hickory st

Lateral

Basin:
Segment (US : DS): **44270:44260**
Intensity: **Low**
Drainage Area (SF): **100**
Surface: **Paved**
Comments:

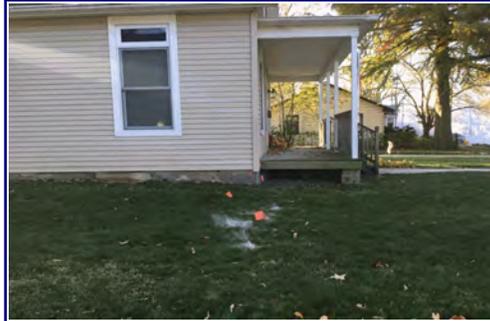
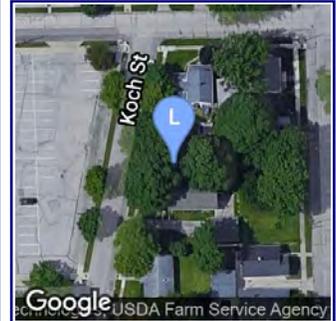
Address: 1206 Koch st

Basin:
Segment (US : DS): **44320:44310**
Intensity: **Low**
Drainage Area (SF): **500**
Surface: **Unpaved**
Comments:

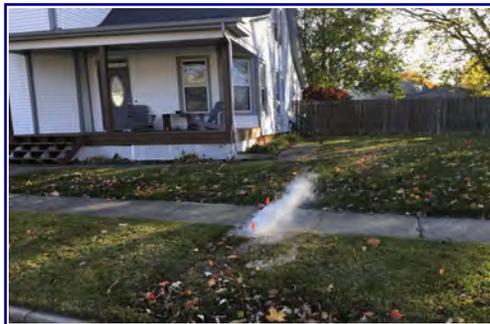
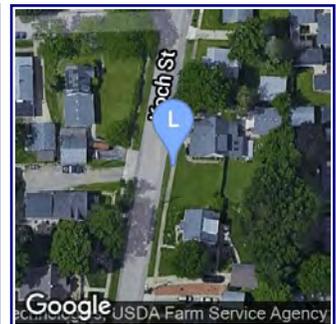
Address: 1212 Koch st

Lateral

Basin:
Segment (US : DS): **44310:43500**
Intensity: **High**
Drainage Area (SF): **200**
Surface: **Unpaved**
Comments:

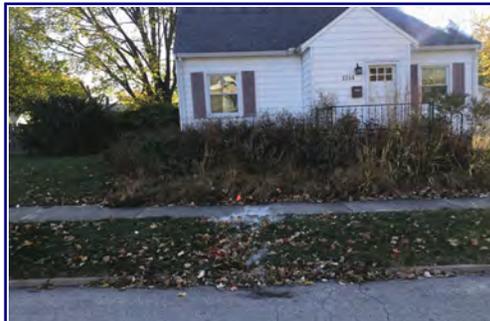
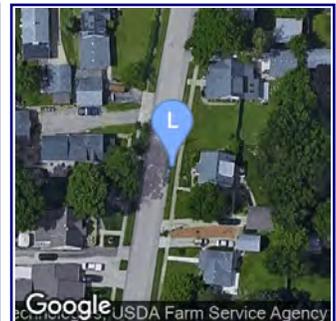
Address: 1214 Koch st

Lateral

Basin:
Segment (US : DS): **44310:43500**
Intensity: **Medium**
Drainage Area (SF): **300**
Surface: **Unpaved**
Comments:

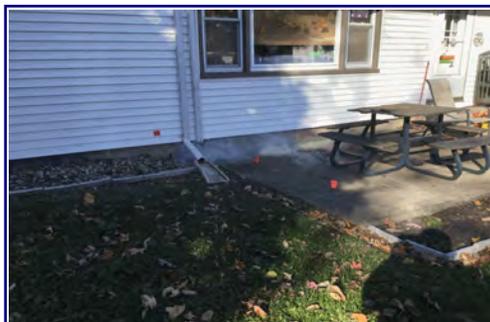
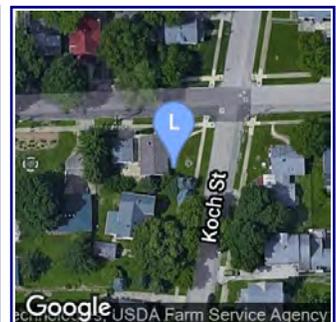
Address: 1301 Koch St

Lateral

Basin:
Segment (US : DS): **44340:43500**
Intensity: **High**
Drainage Area (SF): **300**
Surface: **Paved**
Comments:

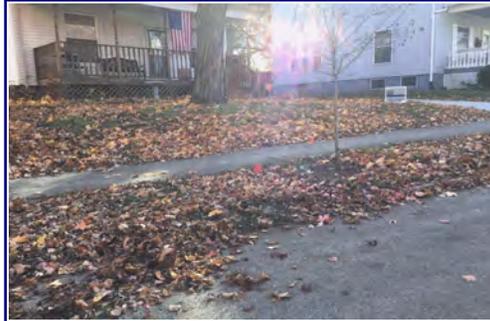
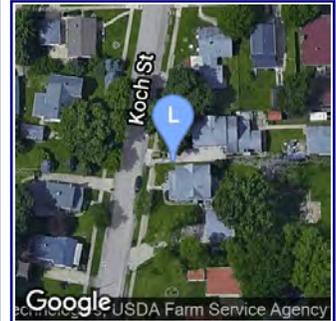
Address: 1304 Koch st

Basin:
Segment (US : DS): **44340:43500**
Intensity: **Low**
Drainage Area (SF): **200**
Surface: **Unpaved**
Comments:

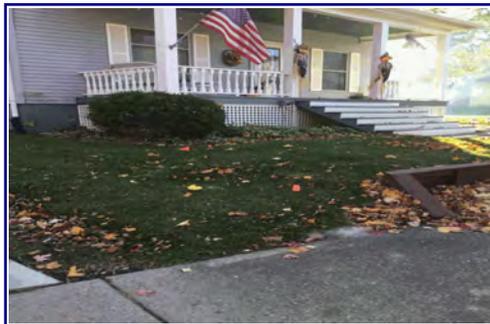
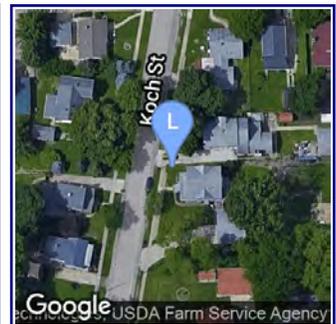
Address: 1306 Koch St

Lateral

Basin:
Segment (US : DS): **44340:43500**
Intensity: **Medium**
Drainage Area (SF): **200**
Surface: **Unpaved**
Comments:

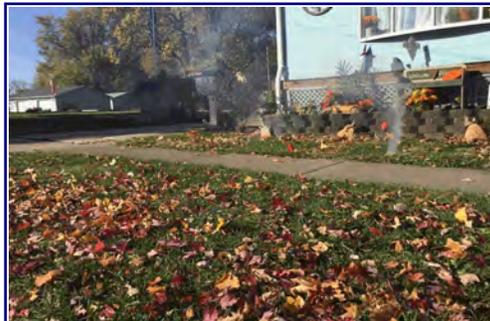
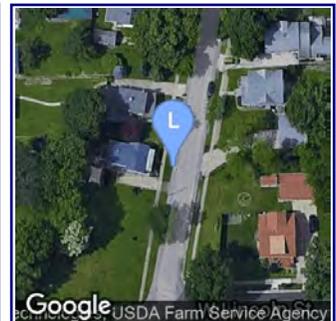
Address: 1311 Koch st

Lateral

Basin:
Segment (US : DS): **44340:43500**
Intensity: **Low**
Drainage Area (SF): **500**
Surface: **Unpaved**
Comments:

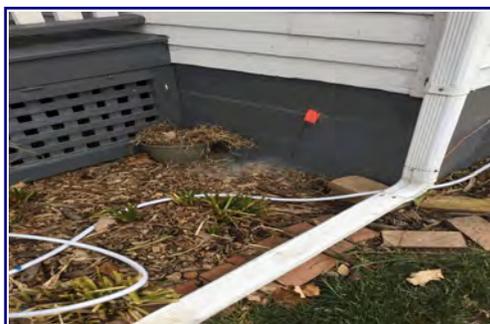
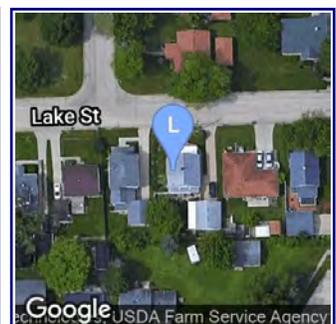
Address: 108 Lake st

Lateral

Basin:
Segment (US : DS): **44120:44110**
Intensity: **Low**
Drainage Area (SF): **300**
Surface: **Unpaved**
Comments:

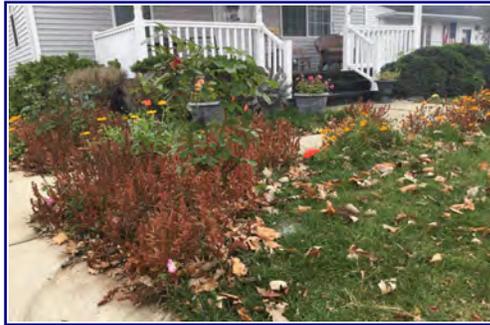
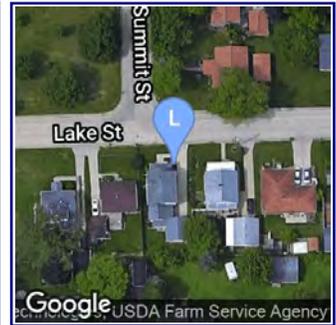
Address: 110 Lake st

Basin:
Segment (US : DS): **44120:44110**
Intensity: **Medium**
Drainage Area (SF): **500**
Surface: **Unpaved**
Comments:

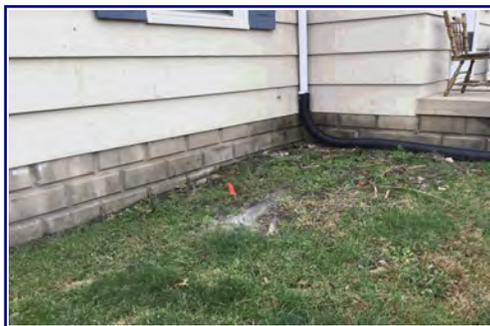
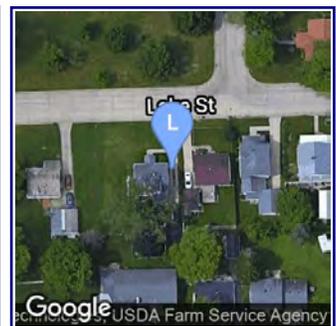
Address: 204 Lake st

Basin:
Segment (US : DS): **44120:44110**
Intensity: **Medium**
Drainage Area (SF): **300**
Surface: **Unpaved**
Comments:

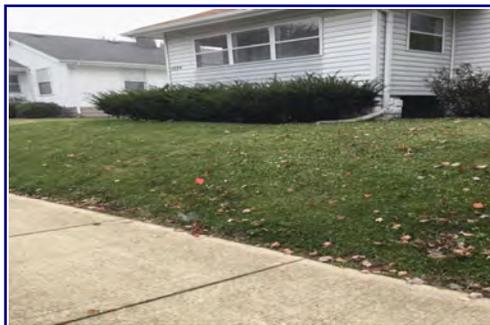
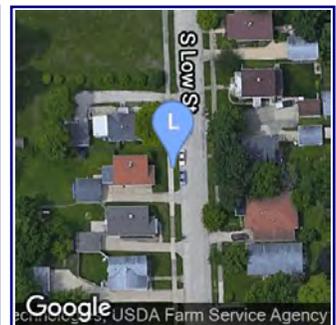
Address: 1225 Low St

Lateral

Basin:
Segment (US : DS): **44090:43450**
Intensity: **Medium**
Drainage Area (SF): **300**
Surface: **Unpaved**
Comments:

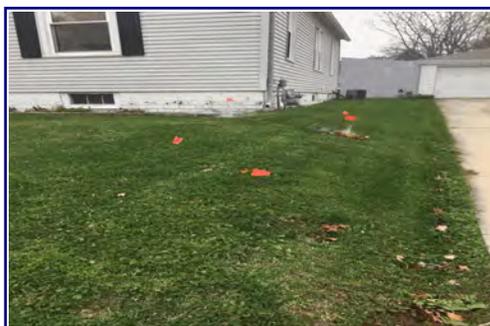
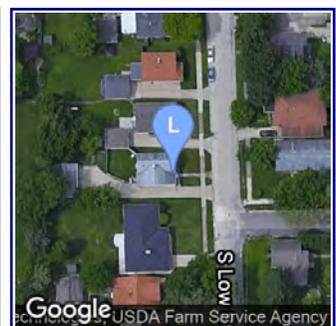
Address: 1229 Low St

Lateral

Basin:
Segment (US : DS): **44090:43450**
Intensity: **High**
Drainage Area (SF): **1,000**
Surface: **Unpaved**
Comments:

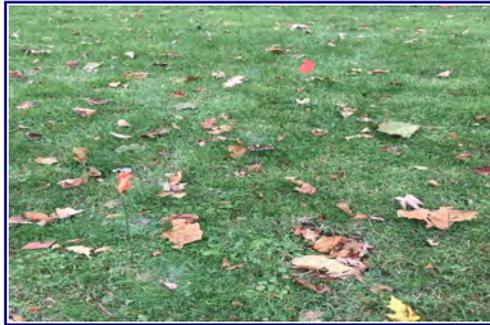
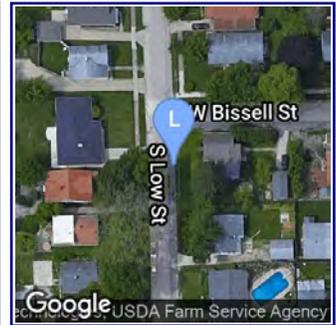
Address: 1302 Low St

Basin:
Segment (US : DS): **44100:44090**
Intensity: **Low**
Drainage Area (SF): **300**
Surface: **Unpaved**
Comments:

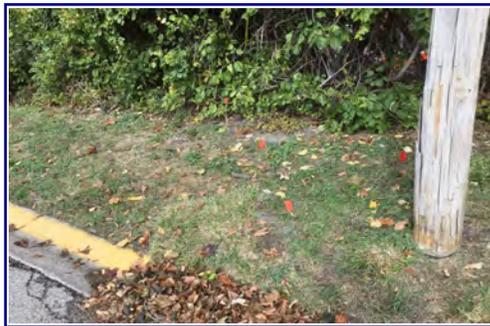
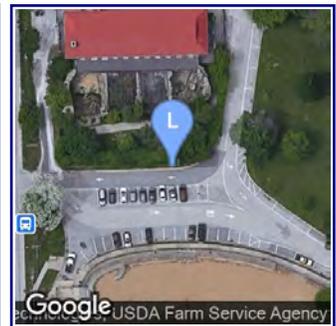
Address: 1105 Morris

Lateral

Basin:
Segment (US : DS): **43404:43402**
Intensity: **Medium**
Drainage Area (SF): **200**
Surface: **Unpaved**
Comments:

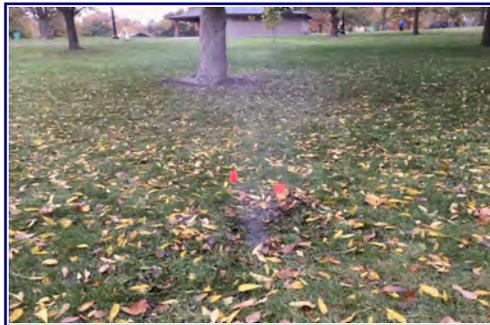
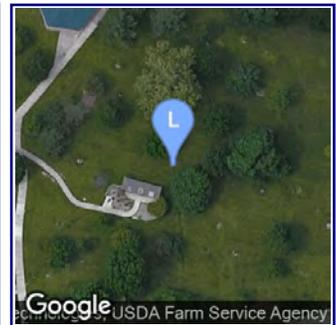
Address: 1122 Morris

Lateral

Basin:
Segment (US : DS): **43410:43408**
Intensity: **Low**
Drainage Area (SF): **500**
Surface: **Unpaved**
Comments:

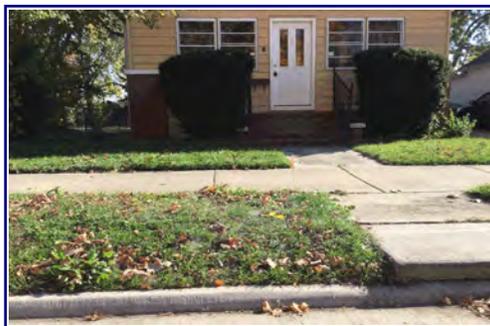
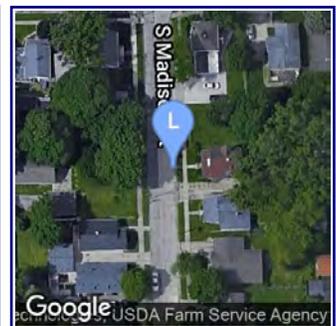
Address: 1102 S madison st

Lateral

Basin:
Segment (US : DS): **44370:44360**
Intensity: **Low**
Drainage Area (SF): **200**
Surface: **Unpaved**
Comments:

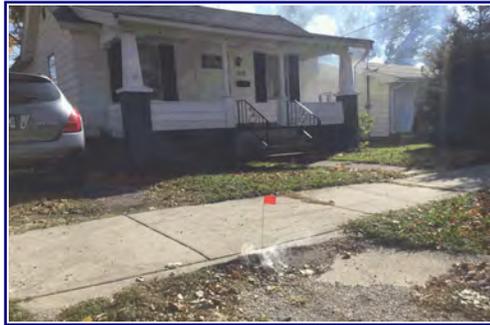
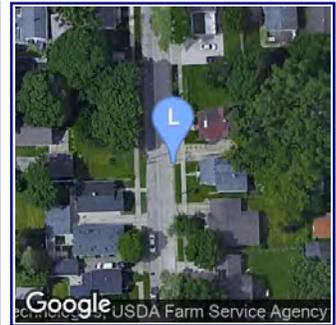
Address: 1104 S madison st

Basin:
Segment (US : DS): **44370:44360**
Intensity: **Medium**
Drainage Area (SF): **100**
Surface: **Paved**
Comments:

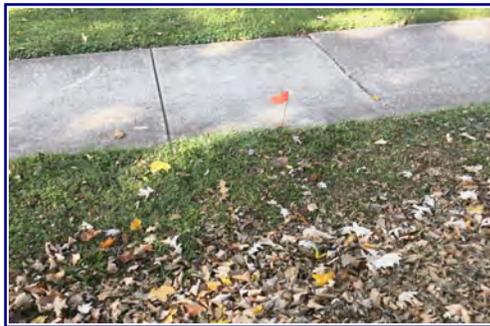
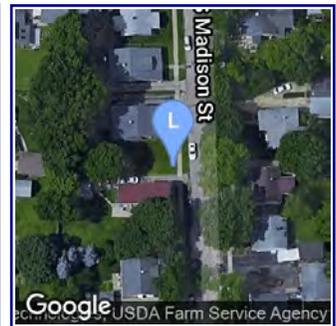
Address: 1113 S madison st

Lateral

Basin:
Segment (US : DS): **44360:44510**
Intensity: **Low**
Drainage Area (SF): **300**
Surface: **Unpaved**
Comments:

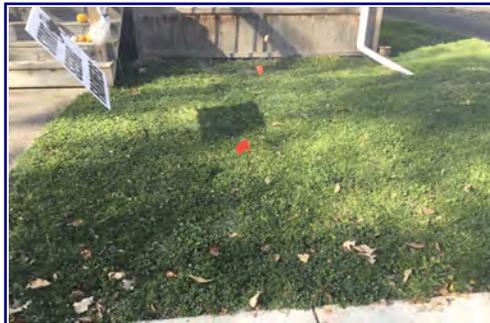
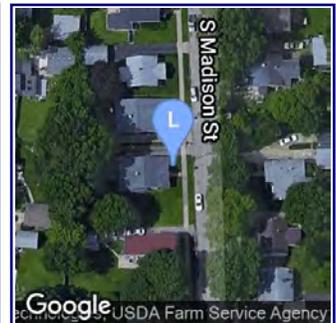
Address: 1113 S Madison St

Lateral

Basin:
Segment (US : DS): **44360:43510**
Intensity: **Medium**
Drainage Area (SF): **500**
Surface: **Unpaved**
Comments:

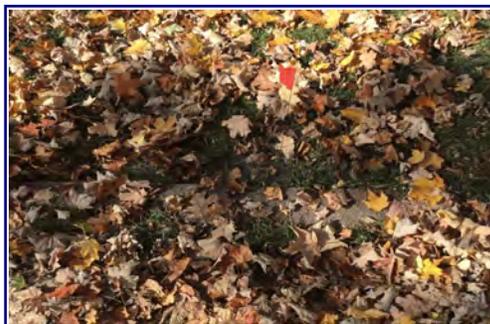
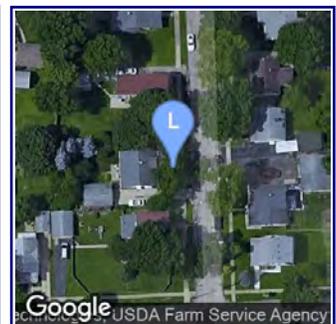
Address: 1211 S madison st

Lateral

Basin:
Segment (US : DS): **44360:44510**
Intensity: **Low**
Drainage Area (SF): **100**
Surface: **Paved**
Comments: *Resident claimed lateral had recently been fixed. Very low smoke.*

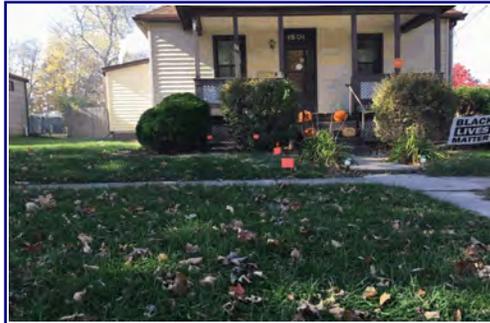
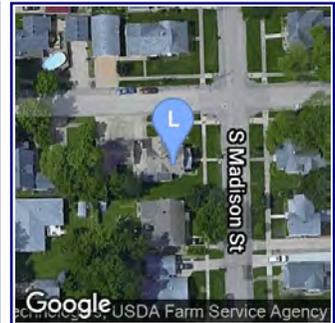
Address: 1501 S madison st

Basin:
Segment (US : DS): **44410:44400**
Intensity: **Low**
Drainage Area (SF): **500**
Surface: **Unpaved**
Comments:

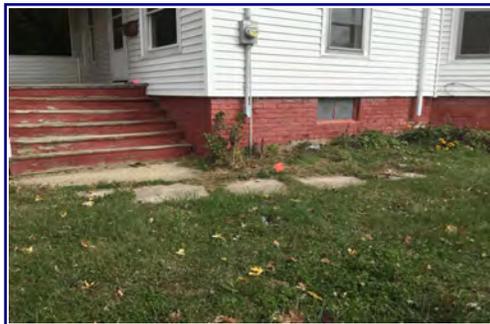
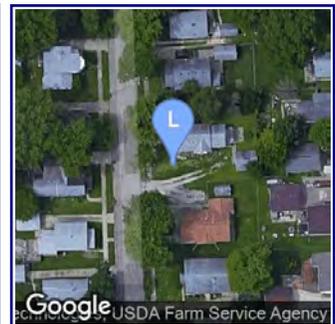
Address: 1208 S Mason St

Lateral

Basin:
Segment (US : DS): **44180:44170**
Intensity: **Medium**
Drainage Area (SF): **300**
Surface: **Unpaved**
Comments:

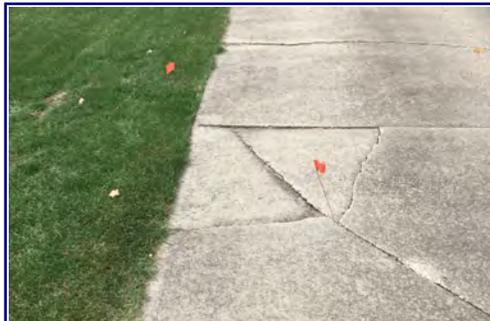
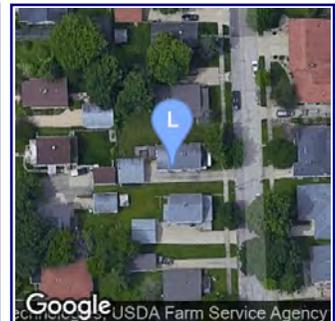
Address: 1223 S mason st

Lateral

Basin:
Segment (US : DS): **44170:43470**
Intensity: **Low**
Drainage Area (SF): **500**
Surface: **Paved**
Comments:

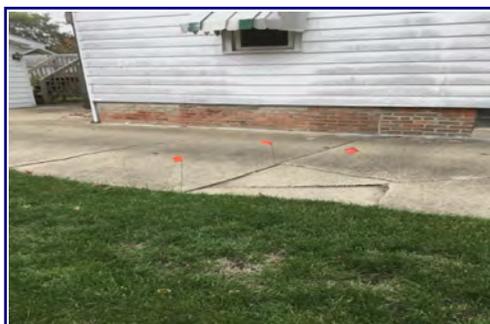
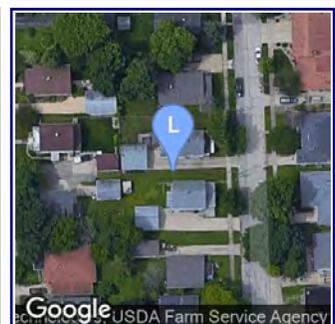
Address: 1223 S Mason St

Lateral

Basin:
Segment (US : DS): **43470:43460**
Intensity: **Low**
Drainage Area (SF): **300**
Surface: **Paved**
Comments:

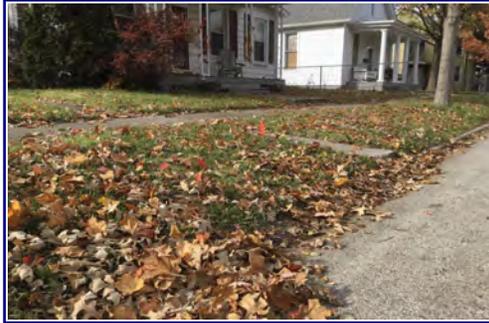
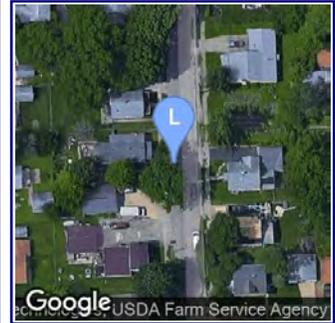
Address: 1109 S Oak St

Basin:
Segment (US : DS): **44390:44260**
Intensity: **Low**
Drainage Area (SF): **500**
Surface: **Unpaved**
Comments:

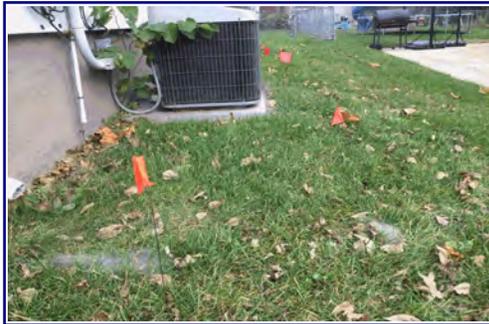
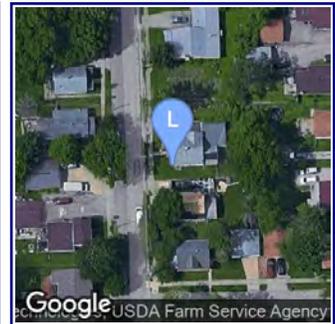
Address: 1110 S oak st

Lateral

Basin:
Segment (US : DS): **44390:44260**
Intensity: **Low**
Drainage Area (SF): **1,000**
Surface: **Unpaved**
Comments:

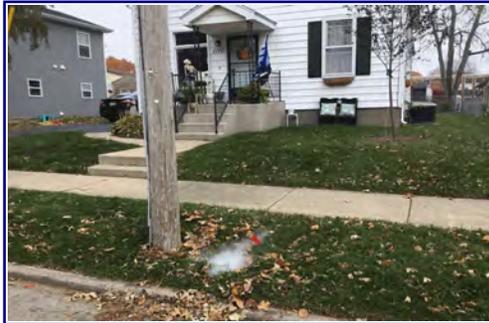
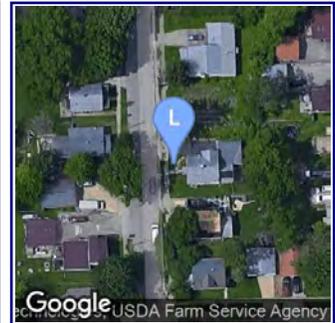
Address: 1110 S oak st

Lateral

Basin:
Segment (US : DS): **44390:44260**
Intensity: **Medium**
Drainage Area (SF): **200**
Surface: **Unpaved**
Comments:

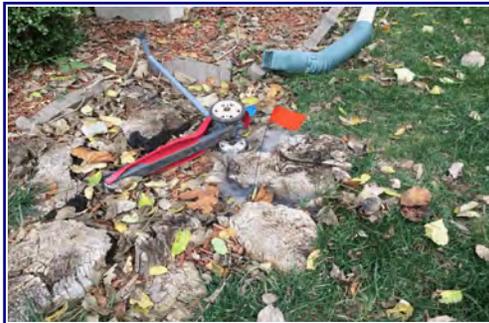
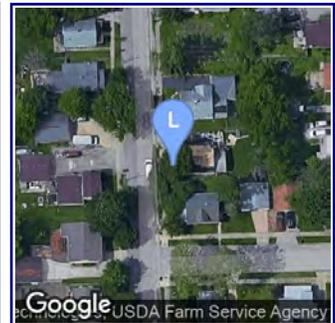
Address: 1112 S oak st

Lateral

Basin:
Segment (US : DS): **44390:44260**
Intensity: **Low**
Drainage Area (SF): **300**
Surface: **Unpaved**
Comments:

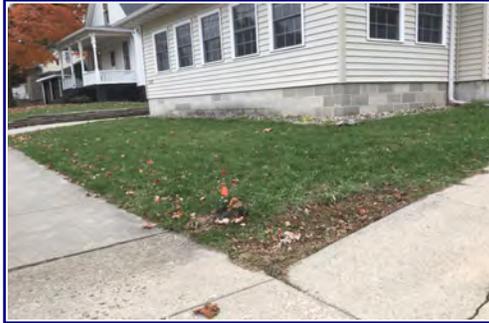
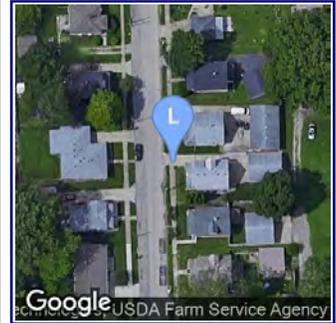
Address: 1208 S Oak St

Basin:
Segment (US : DS): **44250:43490**
Intensity: **Low**
Drainage Area (SF): **300**
Surface: **Unpaved**
Comments:

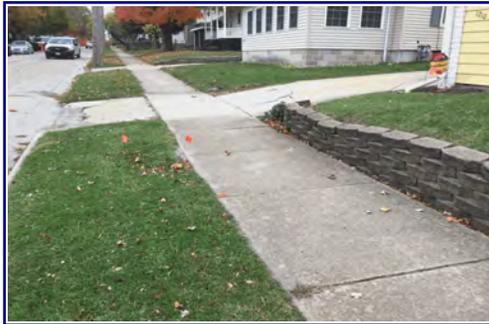
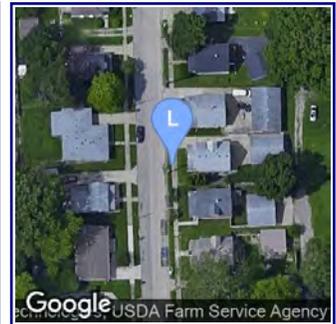
Address: 1210 S Oak St

Basin:
Segment (US : DS): **44250:43490**
Intensity: **Low**
Drainage Area (SF): **200**
Surface: **Unpaved**
Comments:

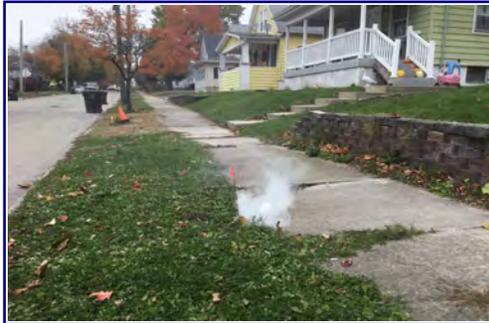
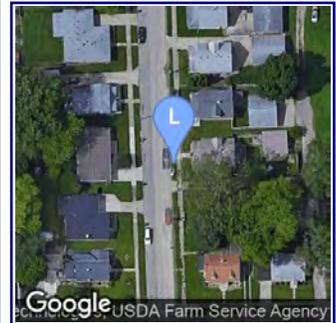
Address: 1214 S Oak St

Lateral

Basin:
Segment (US : DS): **44250:43490**
Intensity: **High**
Drainage Area (SF): **200**
Surface: **Unpaved**
Comments:

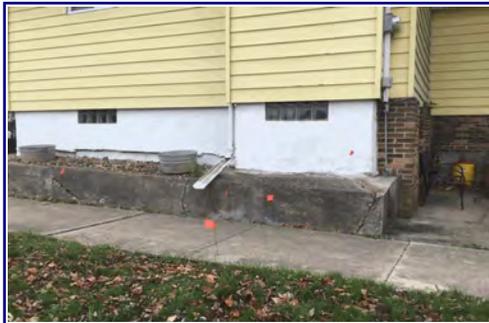
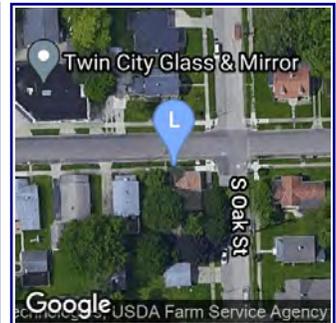
Address: 1301 S Oak St

Lateral

Basin:
Segment (US : DS): **43490:43480**
Intensity: **High**
Drainage Area (SF): **300**
Surface: **Paved**
Comments:
