**2020 SSES PROGRAM CITY
OF BLOOMINGTON, IL
FINAL REPORT**

MAY 2021

PROJECT NO: 11-3577-01

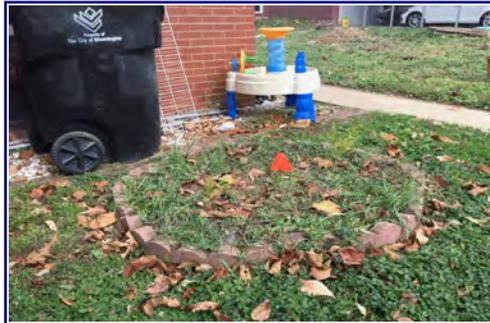
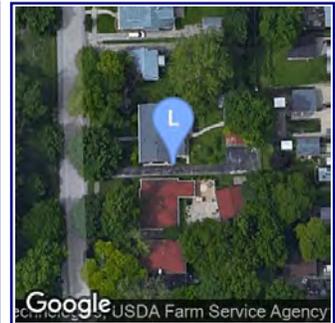
Address: 1010 Summit st

Basin:
Segment (US : DS): **43900:43420**
Intensity: **Medium**
Drainage Area (SF): **300**
Surface: **Unpaved**
Comments:

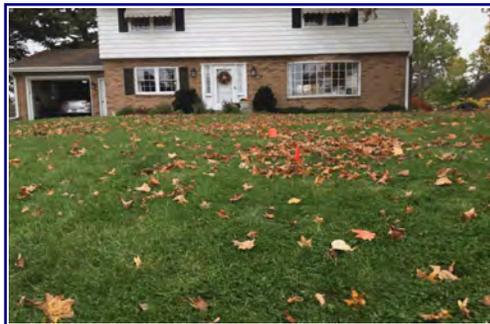
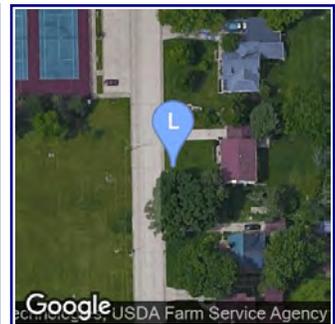
Address: 1108 Summit st

Lateral

Basin:
Segment (US : DS): **43910:43900**
Intensity: **Medium**
Drainage Area (SF): **1,000**
Surface: **Unpaved**
Comments:

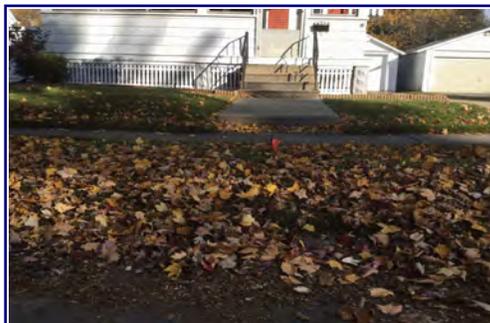
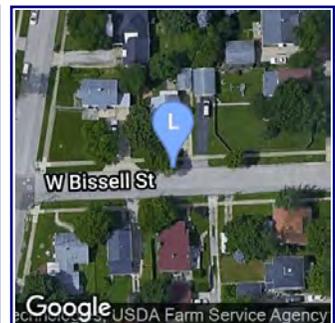
Address: 305 W Bissell St

Lateral

Basin:
Segment (US : DS): **43510:43500**
Intensity: **Low**
Drainage Area (SF): **300**
Surface: **Unpaved**
Comments:

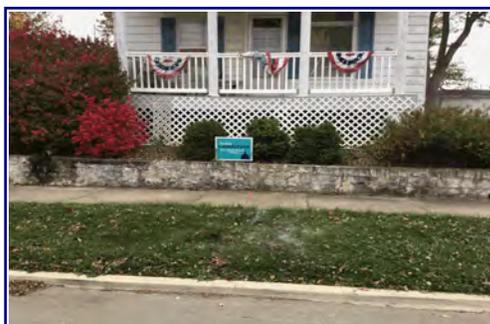
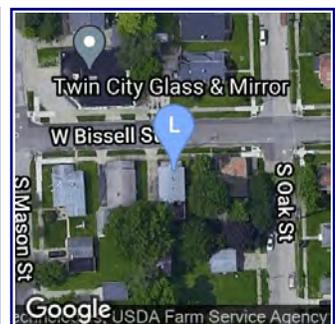
Address: 504 W bissell st

Lateral

Basin:
Segment (US : DS): **43490:43480**
Intensity: **Low**
Drainage Area (SF): **300**
Surface: **Unpaved**
Comments:

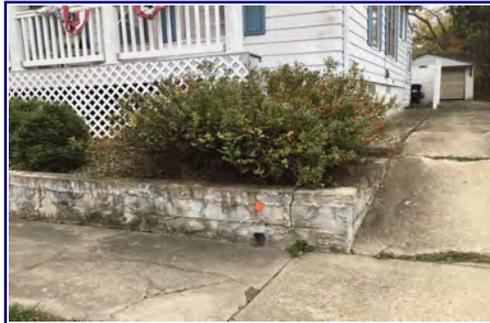
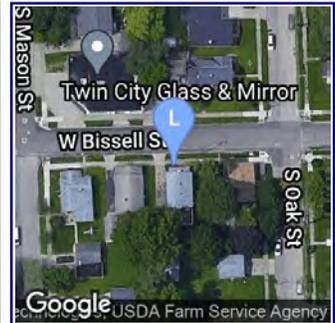
Address: 504 W Bissell St

Basin:
Segment (US : DS): **43490:43480**
Intensity: **Low**
Drainage Area (SF): **300**
Surface: **Paved**
Comments:

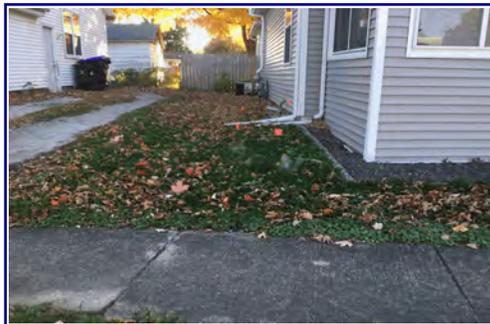
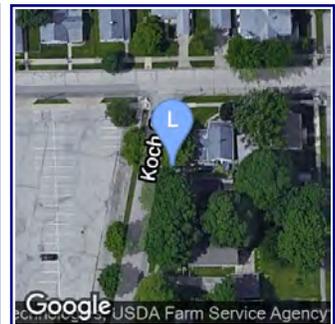
Address: 1204 W Miller St

Lateral

Basin:
Segment (US : DS): **44320:44310**
Intensity: **Medium**
Drainage Area (SF): **300**
Surface: **Unpaved**
Comments:

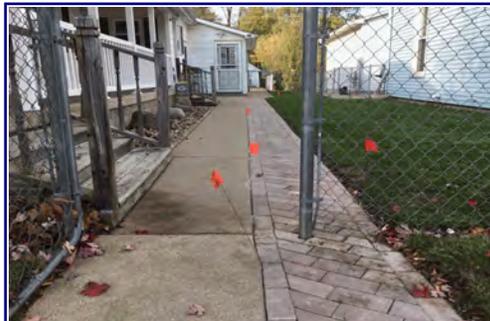
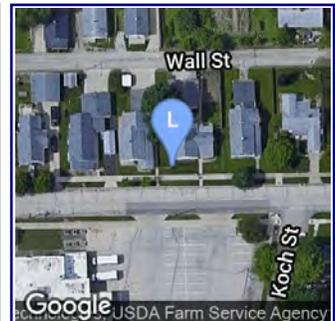
Address: 311 W Miller St

Lateral

Basin:
Segment (US : DS): **44330:44320**
Intensity: **Low**
Drainage Area (SF): **200**
Surface: **Paved**
Comments:

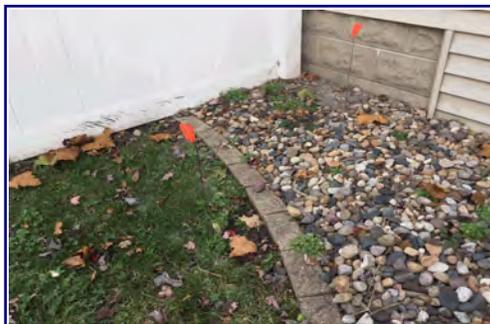
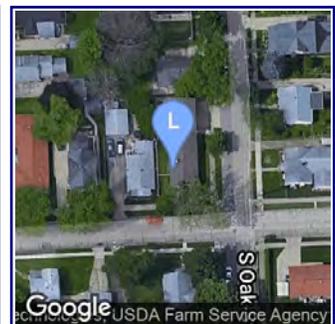
Address: 501 W Miller St

Lateral

Basin:
Segment (US : DS): **44000:43990**
Intensity: **Low**
Drainage Area (SF): **100**
Surface: **Unpaved**
Comments:

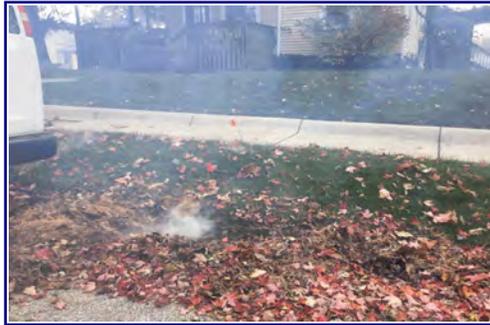
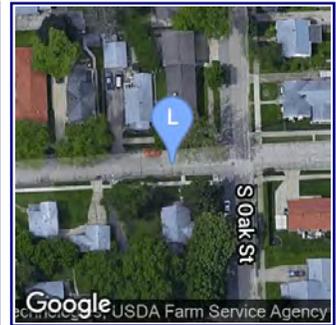
Address: 502 W miller st

Basin:
Segment (US : DS): **44000:43990**
Intensity: **Medium**
Drainage Area (SF): **200**
Surface: **Unpaved**
Comments:

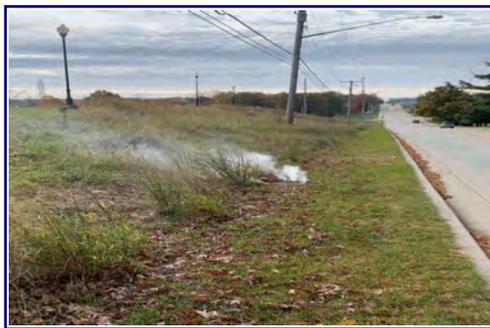
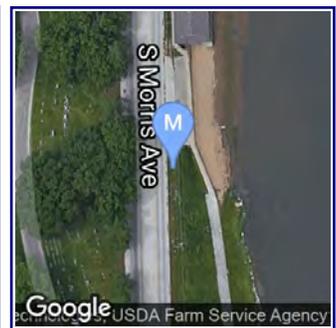
Address: 1020 Bloomington

Manhole (Pick Holes)

Basin:
Segment (US : DS): **43400:43390**
Intensity: **High**
Drainage Area (SF): **200**
Surface: **Unpaved**
Comments:

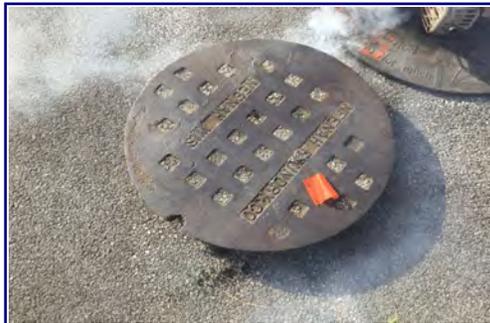
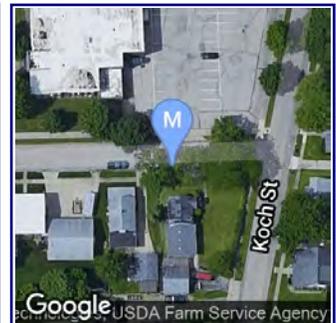
Address: 402 Hickory St

Manhole (Pick Holes)

Basin:
Segment (US : DS): **44280:44270**
Intensity: **Medium**
Drainage Area (SF): **200**
Surface: **Paved**
Comments:

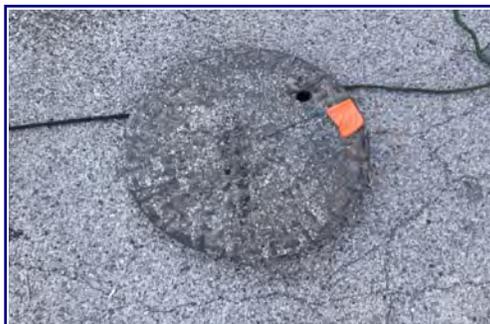
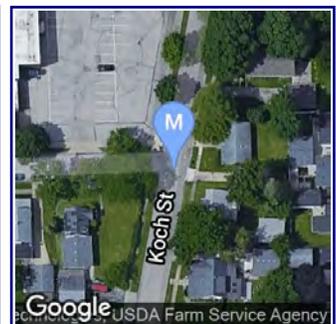
Address: 1208 Koch st

Manhole (Pick Holes)

Basin:
Segment (US : DS): **44310:43500**
Intensity: **Medium**
Drainage Area (SF): **300**
Surface: **Paved**
Comments: *No smoke. Blower is set on respective manhole. ID 44310*

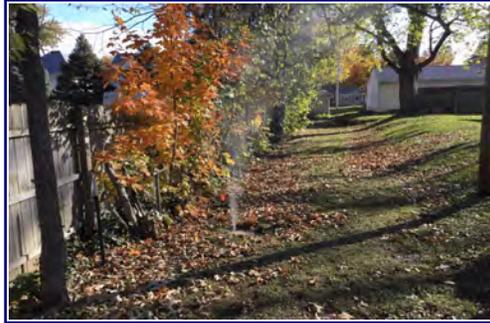
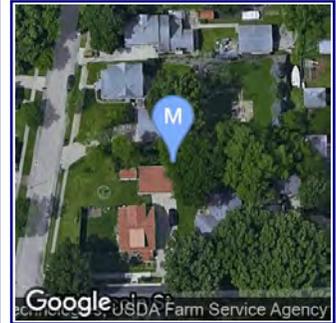
Address: 1312 Koch st

Basin:
Segment (US : DS): **44350:44340**
Intensity: **Medium**
Drainage Area (SF): **300**
Surface: **Unpaved**
Comments:

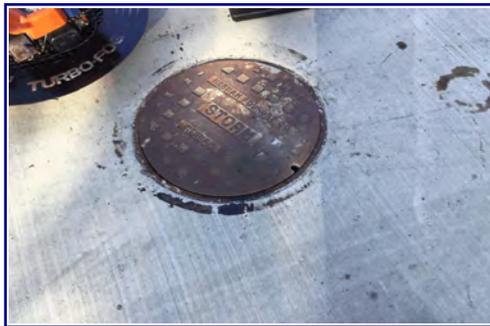
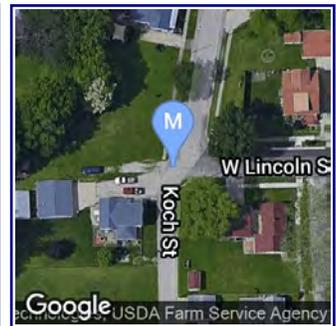
Address: 1315 Koch st

Manhole (Pick Holes)

Basin:
Segment (US : DS): **44380:44340**
Intensity: **Medium**
Drainage Area (SF): **300**
Surface: **Paved**
Comments:

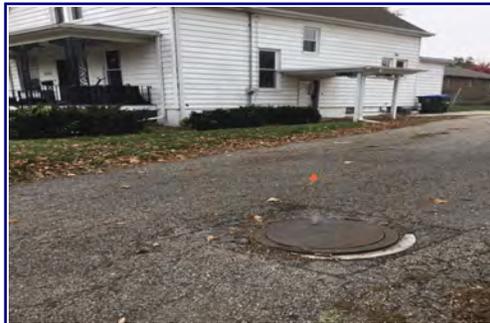
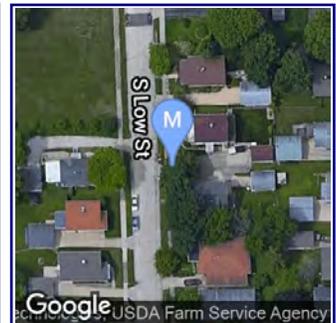
Address: 1222 Low St

Manhole (Pick Holes)

Basin:
Segment (US : DS): **43460:43450**
Intensity: **Medium**
Drainage Area (SF): **200**
Surface: **Unpaved**
Comments:

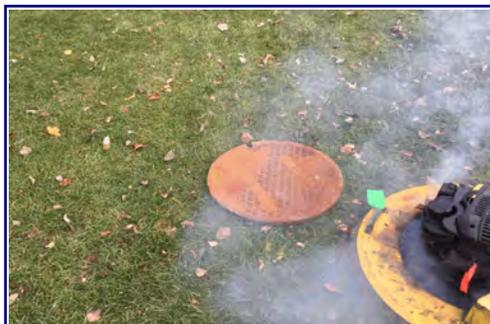
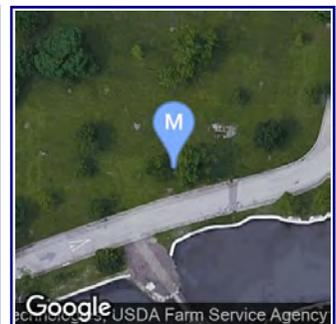
Address: 1122 Morris

Manhole (Pick Holes)

Basin:
Segment (US : DS): **43410:43408**
Intensity: **High**
Drainage Area (SF): **200**
Surface: **Unpaved**
Comments:

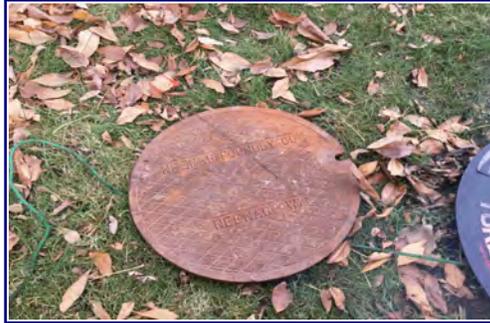
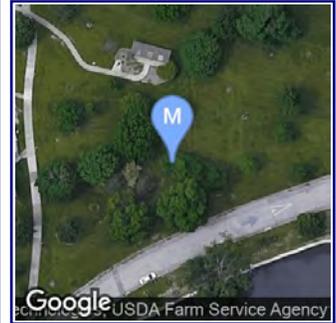
Address: 1122 Morris

Basin:
Segment (US : DS): **43408:43406**
Intensity: **High**
Drainage Area (SF): **200**
Surface: **Unpaved**
Comments:

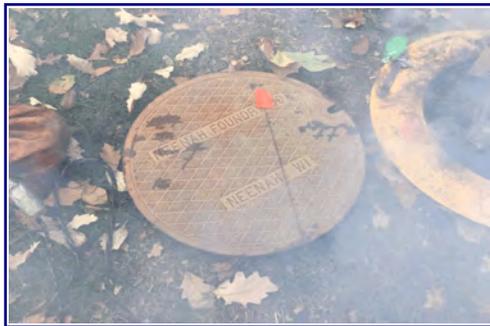
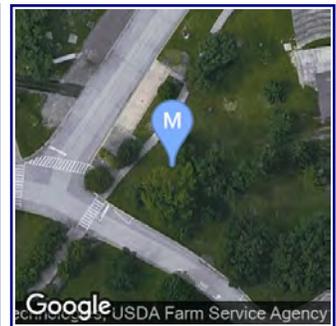
Address: 1122 Morris

Basin:
Segment (US : DS): **43406:43404**
Intensity: **High**
Drainage Area (SF): **200**
Surface: **Unpaved**
Comments:

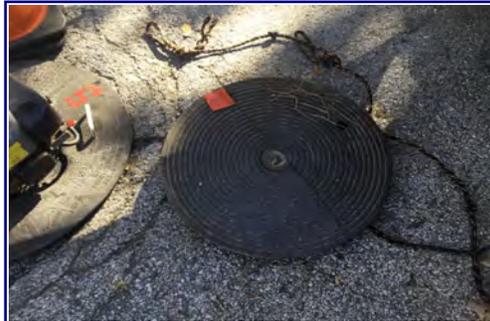
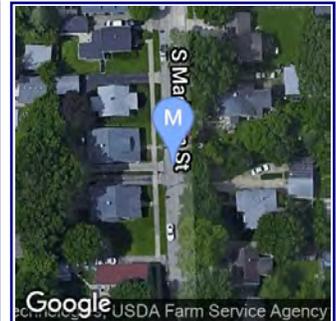
Address: 1111 S Madison St

Manhole (Pick Holes)

Basin:
Segment (US : DS): **44360:43510**
Intensity: **Medium**
Drainage Area (SF): **100**
Surface: **Paved**
Comments:

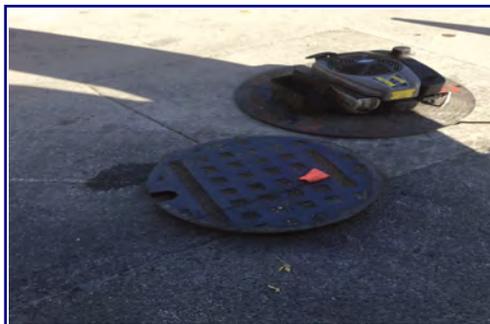
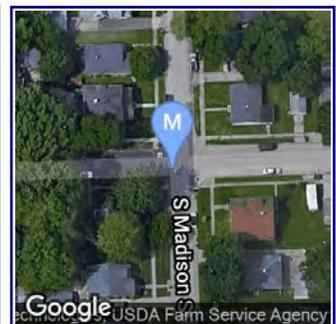
Address: 1401 S Madison St

Manhole (Pick Holes)

Basin:
Segment (US : DS): **43520:43510**
Intensity: **Medium**
Drainage Area (SF): **300**
Surface: **Paved**
Comments:

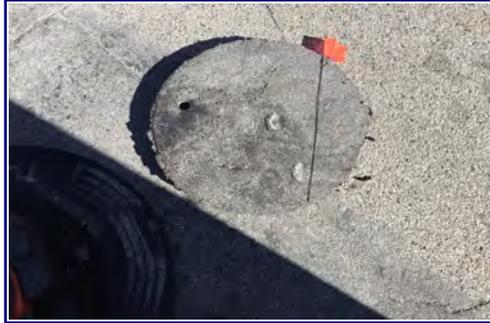
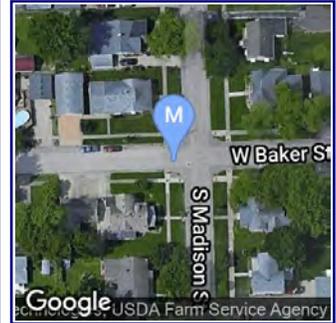
Address: 1501 S madison st

Basin:
Segment (US : DS): **43520:44400**
Intensity: **Low**
Drainage Area (SF): **300**
Surface: **Paved**
Comments:

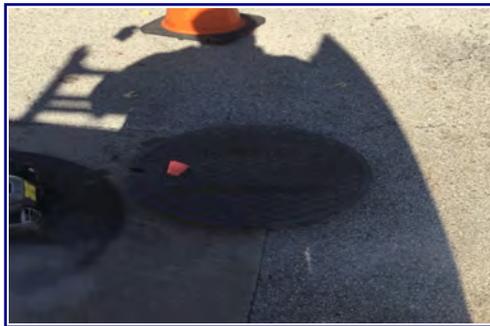
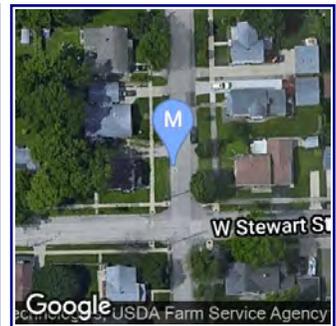
Address: 1507 S Madison St

Manhole (Pick Holes)

Basin:
Segment (US : DS): **44410:44400**
Intensity: **Medium**
Drainage Area (SF): **300**
Surface: **Paved**
Comments:

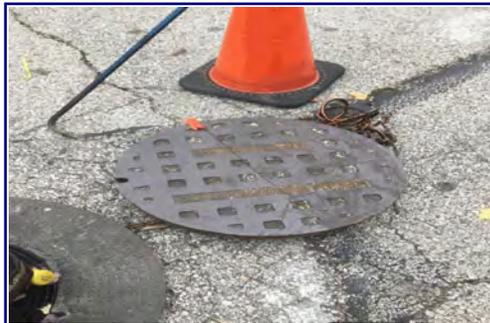
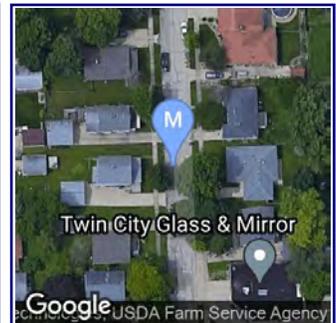
Address: 1223 S Mason St

Manhole (Pick Holes)

Basin:
Segment (US : DS): **43470:43460**
Intensity: **Medium**
Drainage Area (SF): **200**
Surface: **Paved**
Comments:

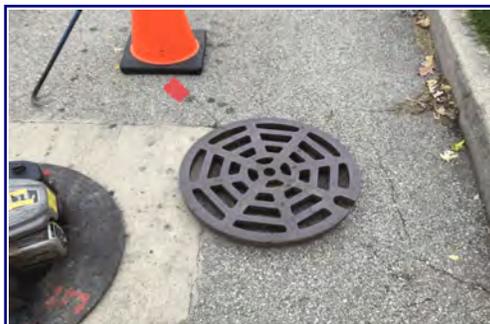
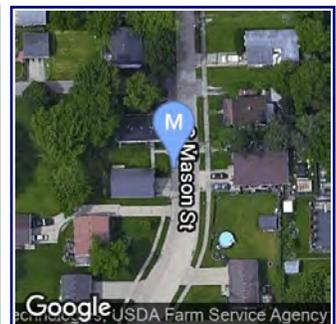
Address: 1409 S Mason St

Manhole (Pick Holes)

Basin:
Segment (US : DS): **44210:43480**
Intensity: **High**
Drainage Area (SF): **1,000**
Surface: **Paved**
Comments: *Vented lid on sanitary*

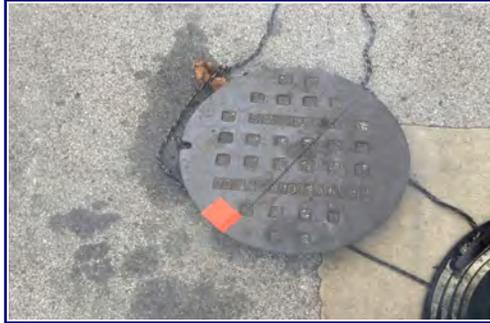
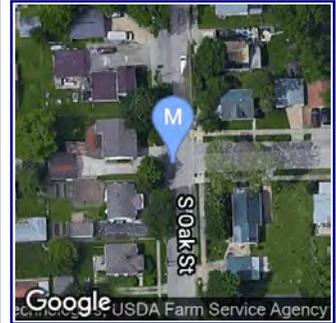
Address: 1113 S oak st

Basin:
Segment (US : DS): **44260:44250**
Intensity: **Low**
Drainage Area (SF): **200**
Surface: **Paved**
Comments: *No smoke. Blower set up on respective manhole.*
MH ID 44260

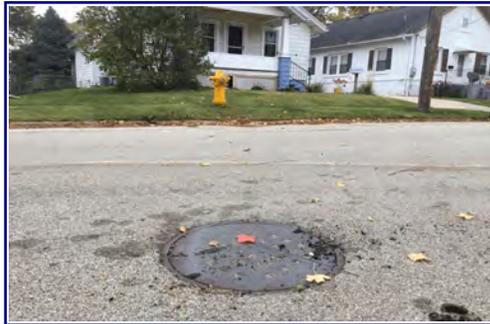
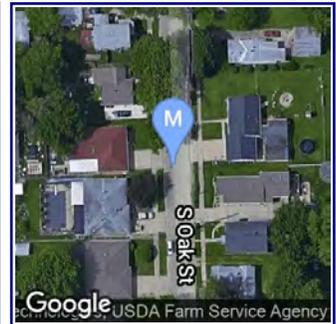
Address: 1311 S oak st

Manhole (Pick Holes)

Basin:
Segment (US : DS): **44290:43490**
Intensity: **Low**
Drainage Area (SF): **300**
Surface: **Paved**
Comments: *MH ID 44290*

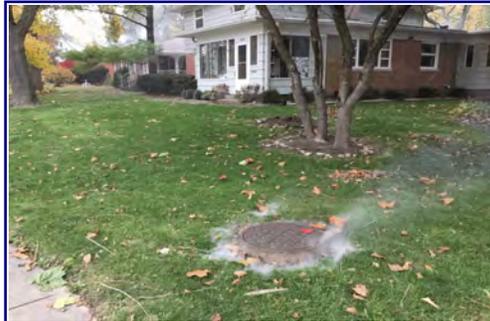
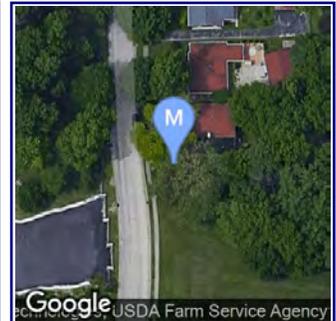
Address: 1014 Summit st

Manhole (Pick Holes)

Basin:
Segment (US : DS): **43430:43420**
Intensity: **Medium**
Drainage Area (SF): **500**
Surface: **Unpaved**
Comments:

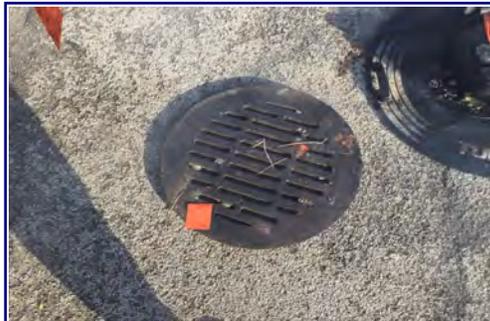
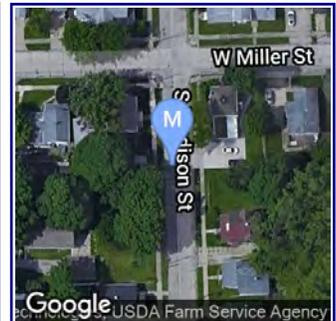
Address: 1102 S madison st

Manhole Cover

Basin:
Segment (US : DS): **44370:44360**
Intensity: **Low**
Drainage Area (SF): **1,000**
Surface: **Paved**
Comments:

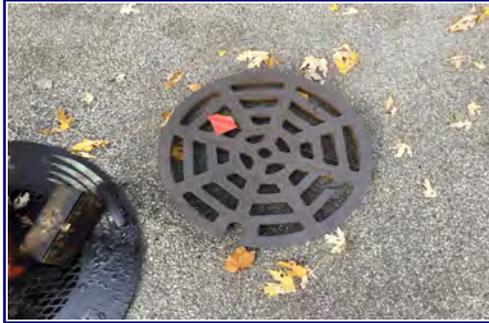
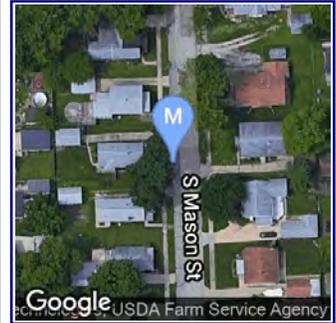
Comments: *No smoke, blower is set up on respective manhole.*

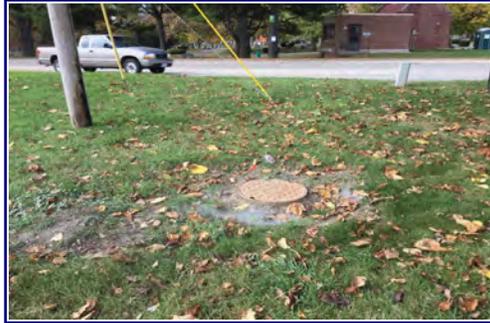
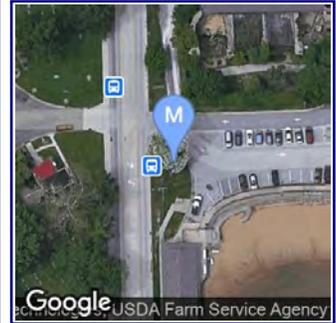
Address: 1105 Morris

Basin:
Segment (US : DS): **43402:43400**
Intensity: **Medium**
Drainage Area (SF): **300**
Surface: **Unpaved**
Comments:

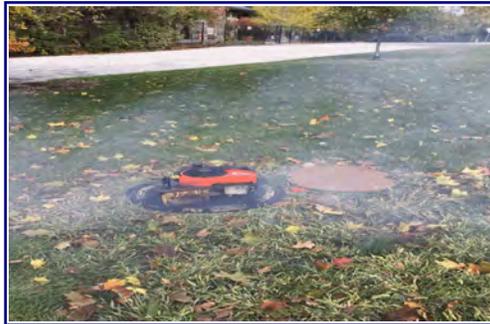
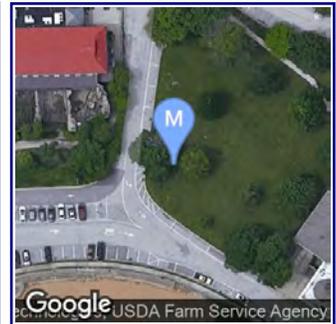
Address: 1105 Morris

Manhole Upstream

Basin:
Segment (US : DS): **43404:43402**
Intensity: **Low**
Drainage Area (SF): **300**
Surface: **Unpaved**
Comments:

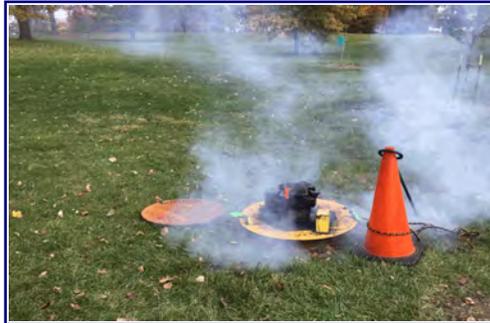
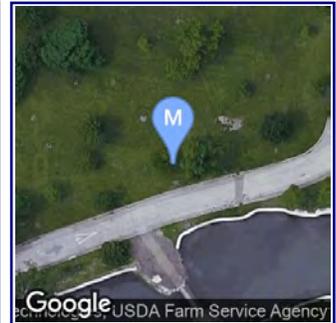
Address: 1122 Morris

Manhole Upstream

Basin:
Segment (US : DS): **43410:43408**
Intensity: **Low**
Drainage Area (SF): **300**
Surface: **Unpaved**
Comments:

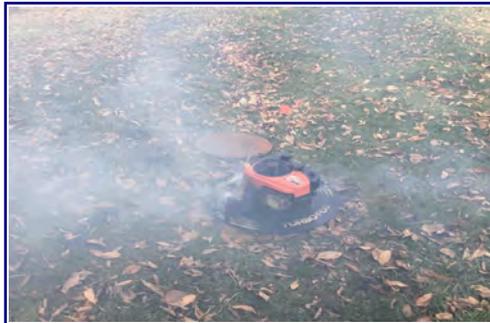
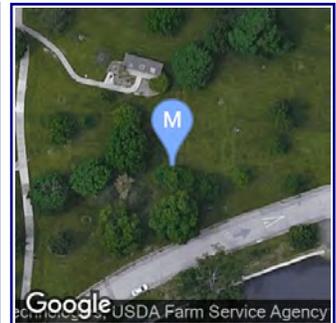
Address: 1122 Morris

Manhole Upstream

Basin:
Segment (US : DS): **43408:43406**
Intensity: **Low**
Drainage Area (SF): **300**
Surface: **Unpaved**
Comments:

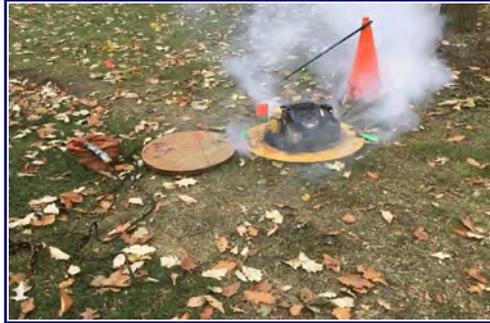
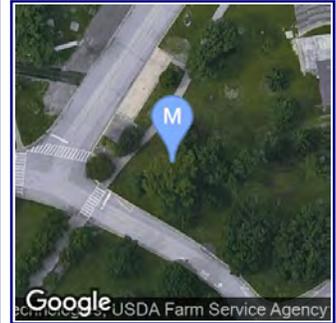
Address: 1122 Morris

Basin:
Segment (US : DS): **43406:43404**
Intensity: **Low**
Drainage Area (SF): **300**
Surface: **Unpaved**
Comments:

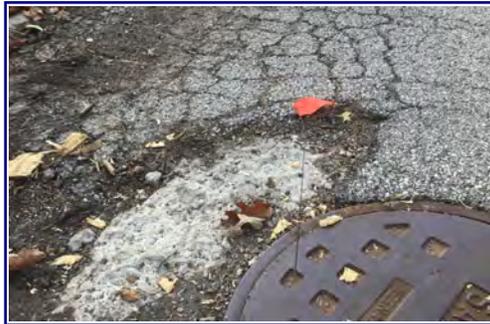
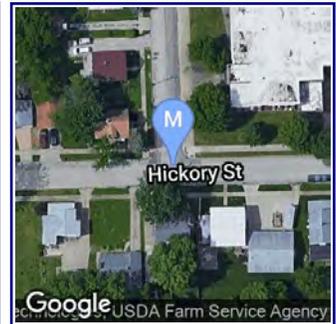
Address: 500 S Lee St

Basin:
Segment (US : DS): **44270:44260**
Intensity: **Low**
Drainage Area (SF): **300**
Surface: **Paved**
Comments:

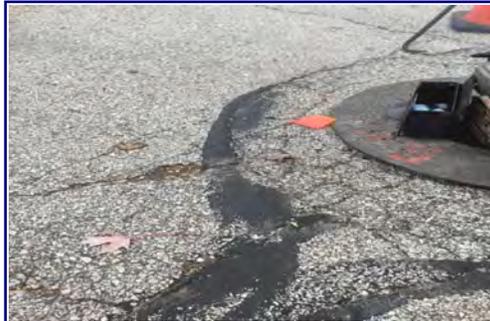
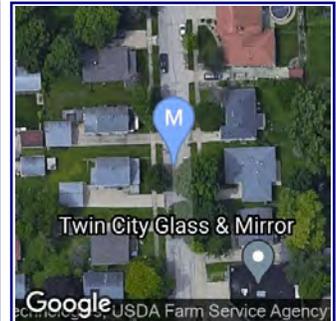
Address: 1223 S Mason St

Manhole Upstream

Basin:
Segment (US : DS): **43470:43460**
Intensity: **Low**
Drainage Area (SF): **300**
Surface: **Paved**
Comments:

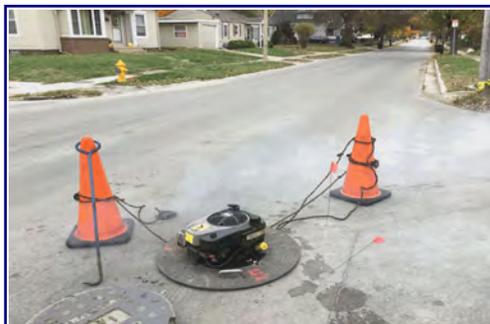
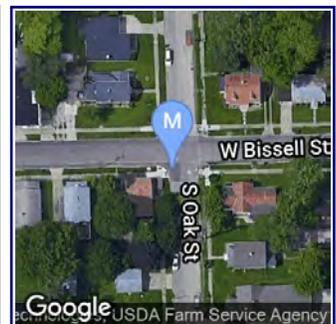
Address: 1301 S Oak St

Manhole Upstream

Basin:
Segment (US : DS): **43490:43480**
Intensity: **Low**
Drainage Area (SF): **300**
Surface: **Paved**
Comments:

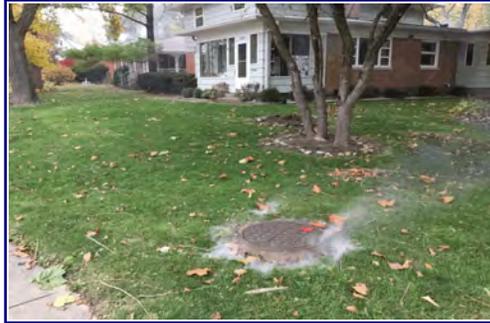
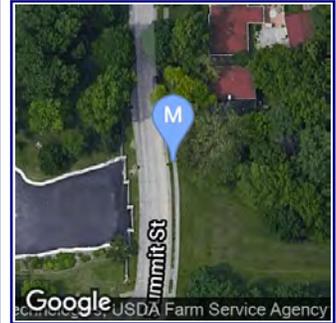
Address: 1014 Summit st

Basin:
Segment (US : DS): **43430:43420**
Intensity: **High**
Drainage Area (SF): **200**
Surface: **Unpaved**
Comments:

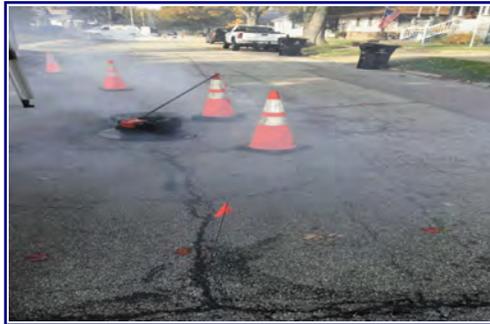
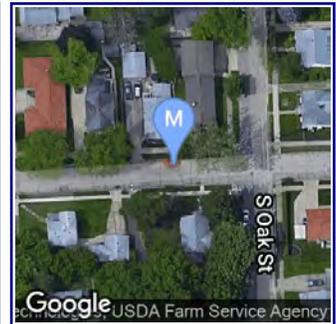
Address: 501 W Miller St

Manhole Upstream

Basin:
Segment (US : DS): **44000:43990**
Intensity: **Medium**
Drainage Area (SF): **500**
Surface: **Paved**
Comments:

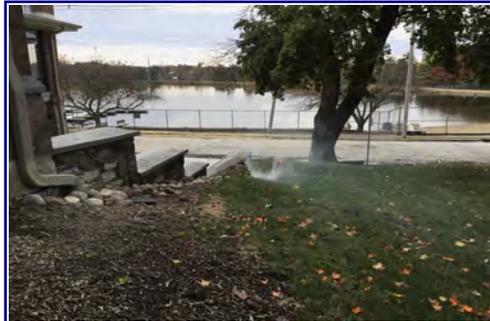
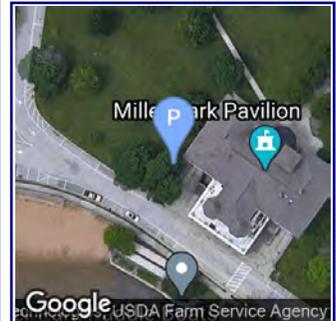
Address: 1122 Morris

Private Sanitary Manhole

Basin:
Segment (US : DS): **43406:43404**
Intensity: **High**
Drainage Area (SF): **300**
Surface: **Unpaved**
Comments:

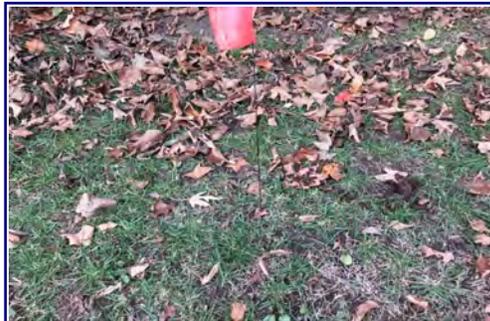
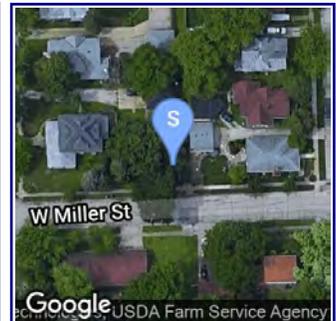
Address: 1101 Low st

Sanitary Mainline

Basin:
Segment (US : DS): **UNKNOWN:43960**
Intensity: **Low**
Drainage Area (SF): **1,000**
Surface: **Unpaved**
Comments:

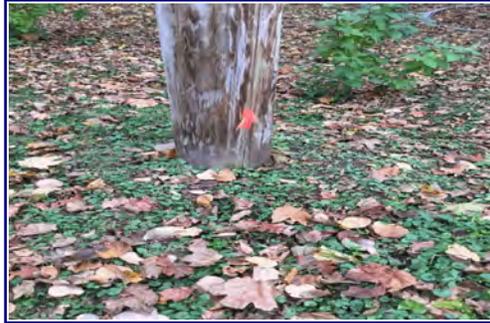
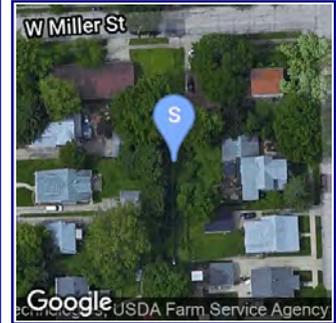
Address: 1105 Low St

Basin:
Segment (US : DS): **43960:43440**
Intensity: **Low**
Drainage Area (SF): **200**
Surface: **Unpaved**
Comments:

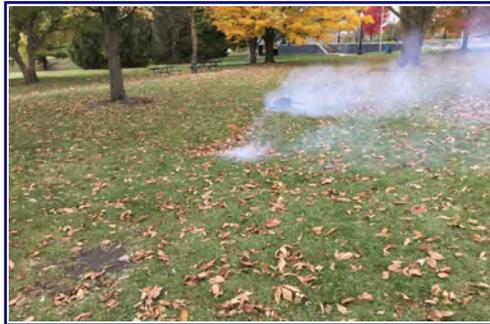
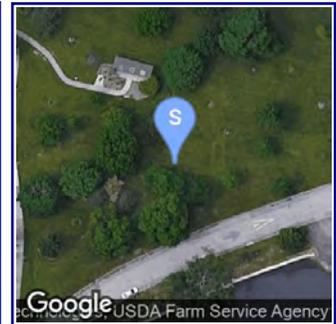
Address: 1122 Morris

Sanitary Mainline

Basin:
Segment (US : DS): **43410:43408**
Intensity: **Medium**
Drainage Area (SF): **500**
Surface: **Unpaved**
Comments:

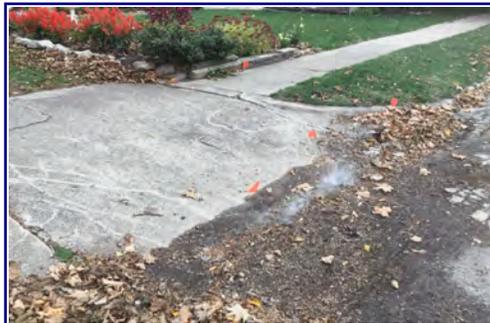
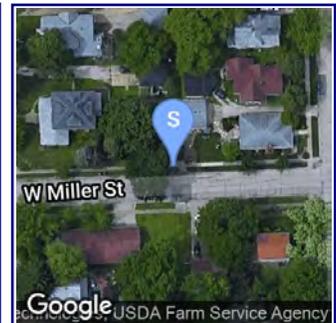
Address: 920 Summit St

Sanitary Mainline

Basin:
Segment (US : DS): **UNKNOWN:43960**
Intensity: **Medium**
Drainage Area (SF): **300**
Surface: **Unpaved**
Comments:

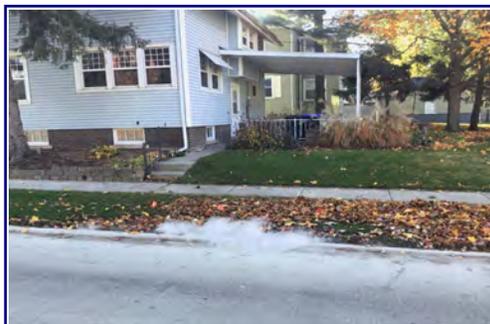
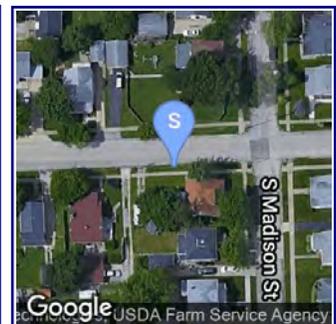
Address: 300 W bissell st

Sanitary Mainline

Basin:
Segment (US : DS): **43510:43500**
Intensity: **High**
Drainage Area (SF): **300**
Surface: **Paved**
Comments:

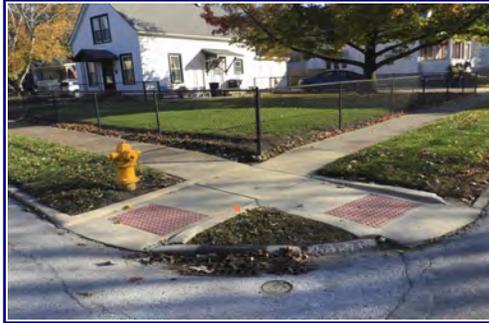
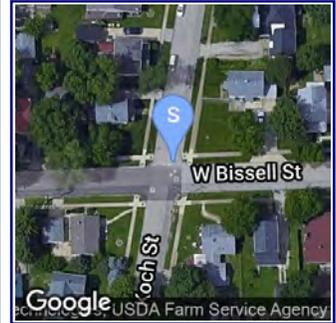
Address: 1220 Koch st

Basin:
Segment (US : DS): **43510:43500**
Intensity: **Low**
Drainage Area (SF): **1,000**
Surface: **Paved**
Comments:

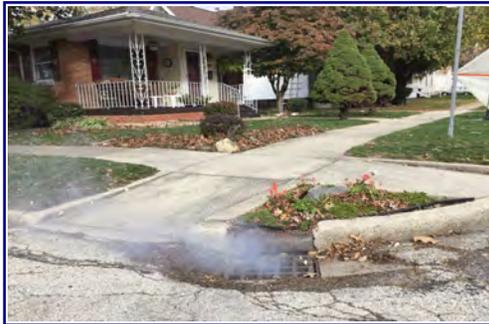
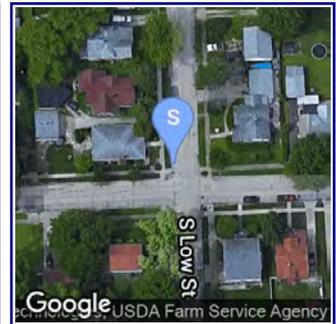
Address: 1009 Low st

Storm Inlet

Basin:
Segment (US : DS): **43980:43970**
Intensity: **High**
Drainage Area (SF): **1,000**
Surface: **Paved**
Comments:

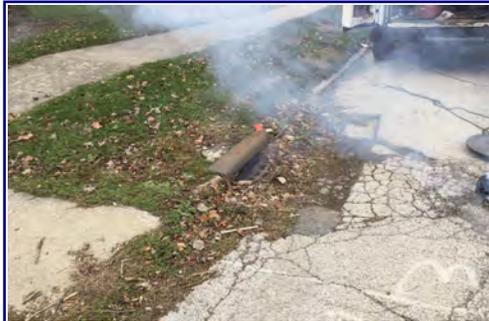
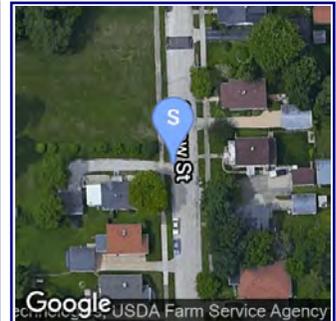
Address: 1223 Low St

Storm Inlet

Basin:
Segment (US : DS): **44090:43450**
Intensity: **Low**
Drainage Area (SF): **1,000**
Surface: **Paved**
Comments:

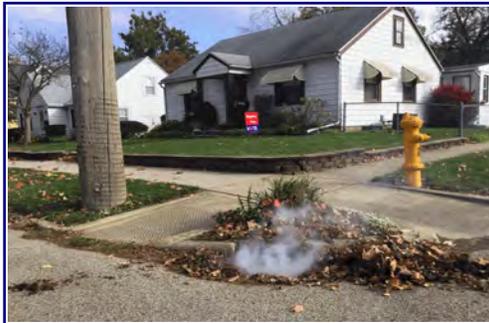
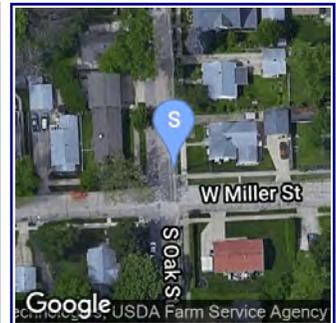
Address: 1008 Oak st

Storm Inlet

Basin:
Segment (US : DS): **44000:43990**
Intensity: **High**
Drainage Area (SF): **1,000**
Surface: **Paved**
Comments:

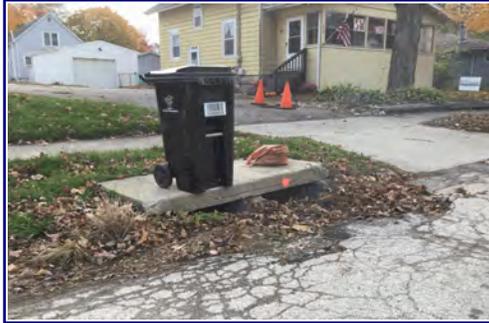
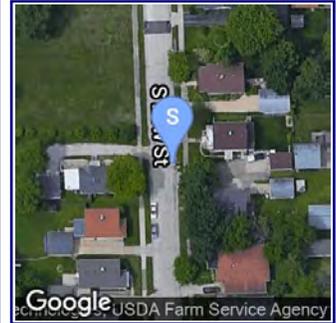
Address: 1222 S Low St

Basin:
Segment (US : DS): **UNKNOWN:43460**
Intensity: **Low**
Drainage Area (SF): **300**
Surface: **Unpaved**
Comments: *Possible Residual smoke from nearby inlets*

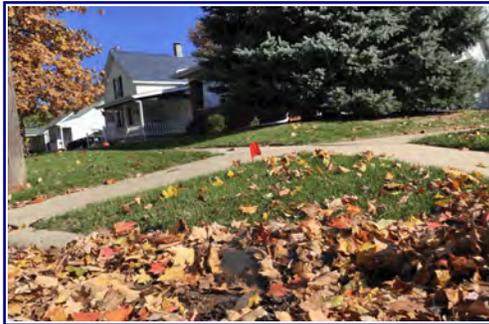
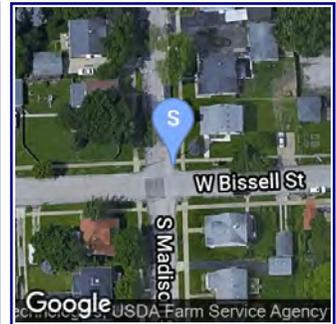
Address: 1214 S madison st

Storm Inlet

Basin:
Segment (US : DS): **43510 :43520**
Intensity: **Low**
Drainage Area (SF): **1,000**
Surface: **Paved**
Comments:

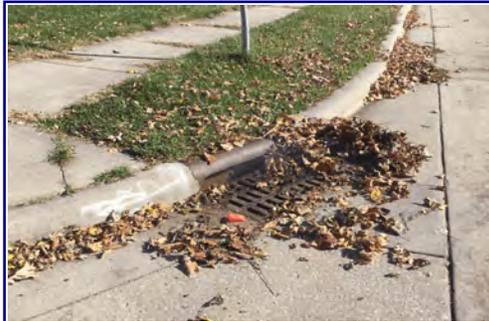
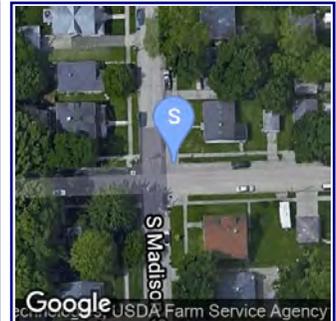
Address: 1314 S Madison St

Storm Inlet

Basin:
Segment (US : DS): **43520:43510**
Intensity: **Medium**
Drainage Area (SF): **1,000**
Surface: **Paved**
Comments:

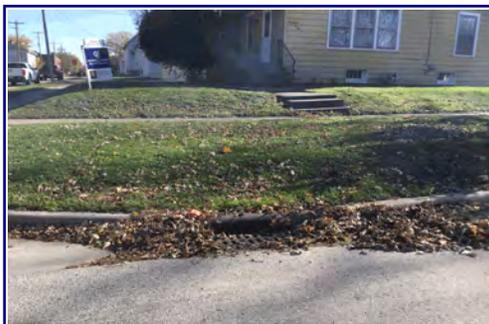
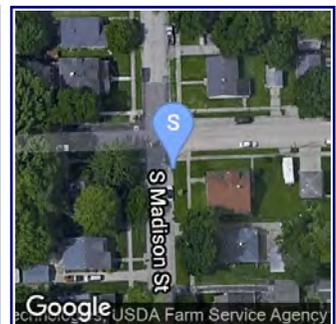
Address: 1402 S Madison St

Storm Inlet

Basin:
Segment (US : DS): **43520:43510**
Intensity: **Medium**
Drainage Area (SF): **300**
Surface: **Unpaved**
Comments:

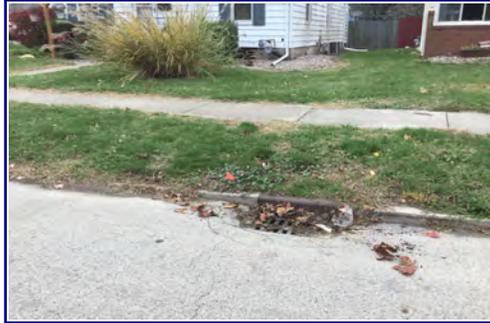
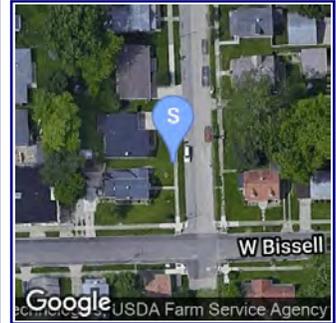
Address: 1213 S Oak St

Basin:
Segment (US : DS): **44250:43490**
Intensity: **Medium**
Drainage Area (SF): **500**
Surface: **Paved**
Comments:

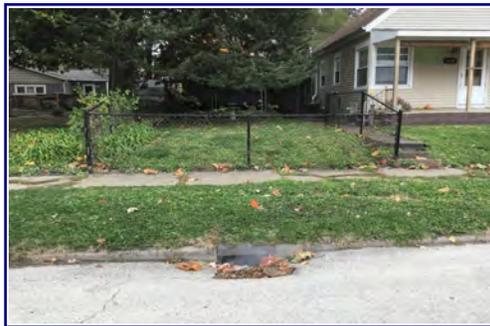
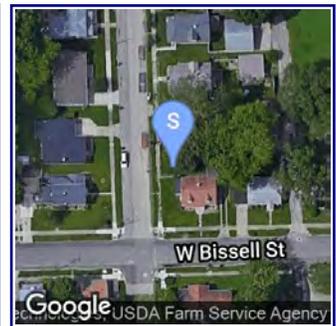
Address: 409 S oak st

Basin:
Segment (US : DS): **44250:43490**
Intensity: **Medium**
Drainage Area (SF): **1,000**
Surface: **Paved**
Comments:

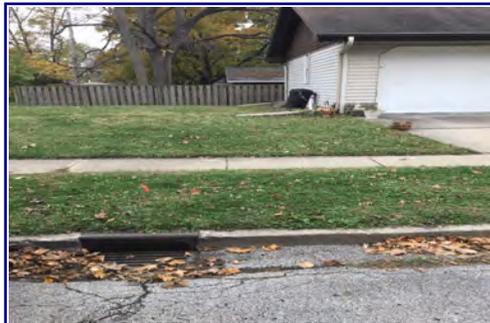
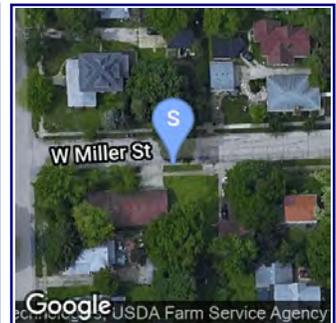
Address: 1002 Summit

Storm Inlet

Basin:
Segment (US : DS): **43960:43440**
Intensity: **Low**
Drainage Area (SF): **300**
Surface: **Paved**
Comments:

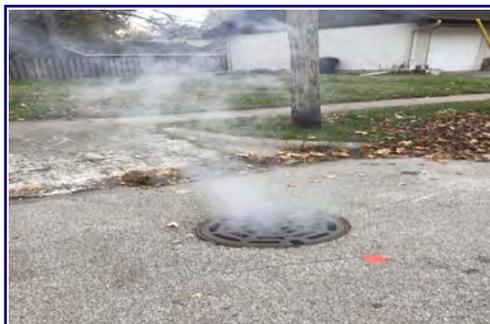
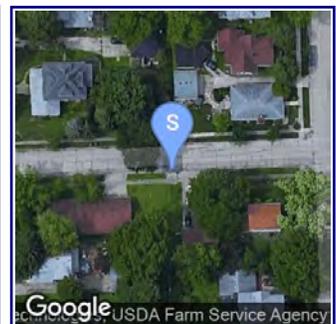
Address: 1002 Summit

Storm Inlet

Basin:
Segment (US : DS): **43960:43440**
Intensity: **High**
Drainage Area (SF): **1,000**
Surface: **Paved**
Comments:

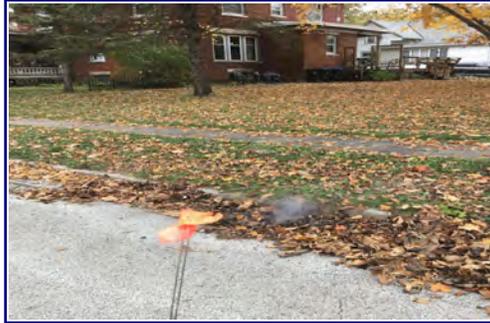
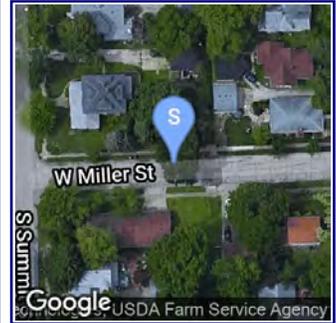
Address: 920 Summit

Basin:
Segment (US : DS): **43960:43440**
Intensity: **Medium**
Drainage Area (SF): **300**
Surface: **Unpaved**
Comments:

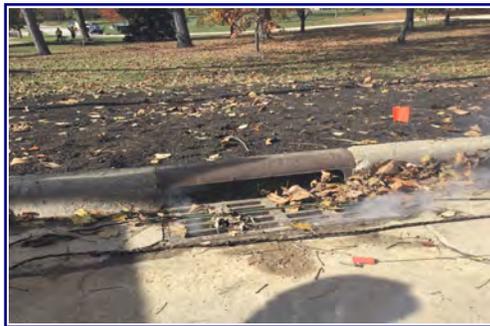
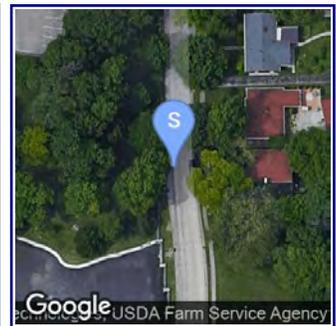
Address: 1014 Summit st

Storm Inlet

Basin:
Segment (US : DS): **43420:43410**
Intensity: **Medium**
Drainage Area (SF): **1,000**
Surface: **Paved**
Comments:

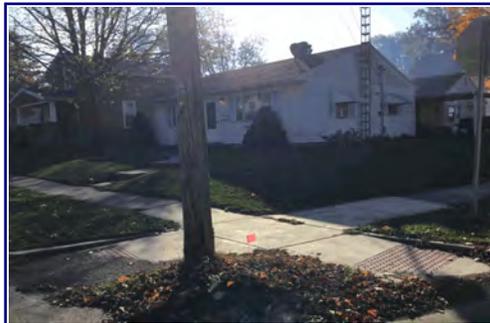
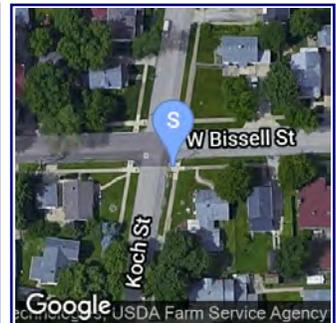
Address: 306 W bissell st

Storm Inlet

Basin:
Segment (US : DS): **43510:43500**
Intensity: **Low**
Drainage Area (SF): **1,000**
Surface: **Paved**
Comments:

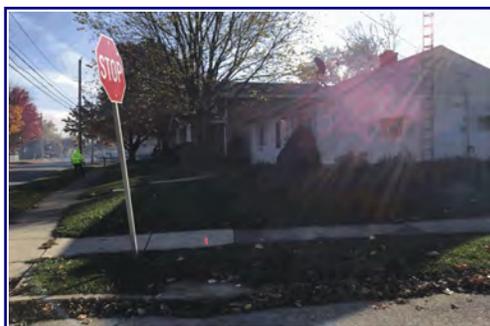
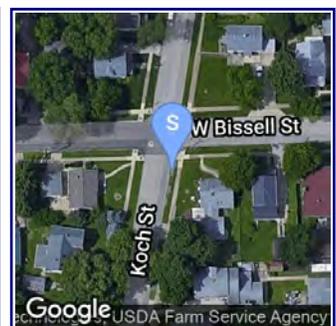
Address: 306 W bissell st

Storm Inlet

Basin:
Segment (US : DS): **43510:43500**
Intensity: **Low**
Drainage Area (SF): **1,000**
Surface: **Paved**
Comments:

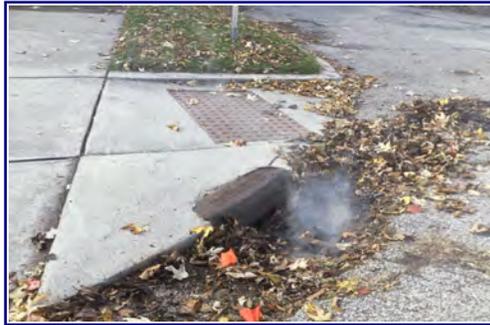
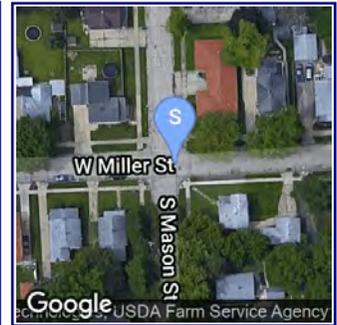
Address: 1202 W Miller St

Basin:
Segment (US : DS): **43990:43980**
Intensity: **Medium**
Drainage Area (SF): **500**
Surface: **Unpaved**
Comments:

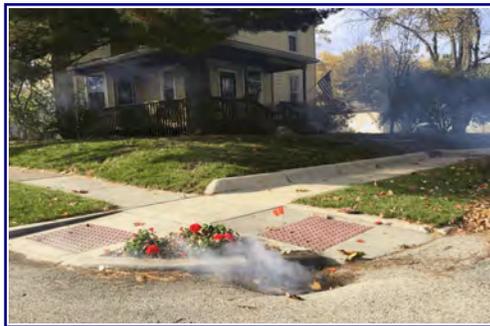
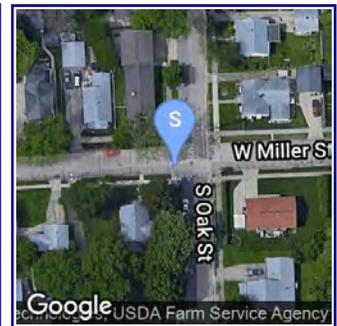
Address: 502 W miller st

Storm Inlet

Basin:
Segment (US : DS): **44000:43990**
Intensity: **High**
Drainage Area (SF): **1,000**
Surface: **Paved**
Comments:

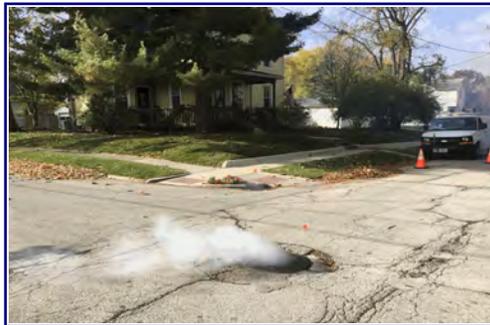
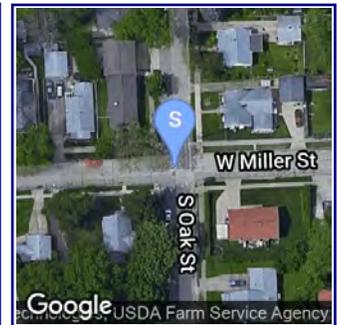
Address: 502 W miller st

Storm Inlet

Basin:
Segment (US : DS): **44000:43990**
Intensity: **High**
Drainage Area (SF): **1,000**
Surface: **Paved**
Comments: *Middle of intersection. Oak st and miller st.*

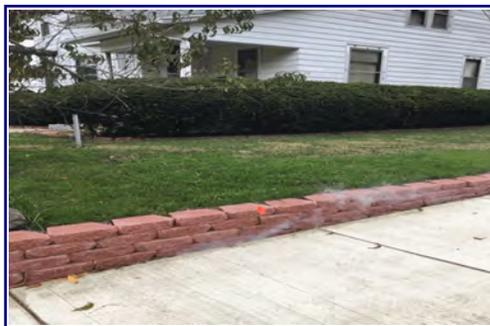
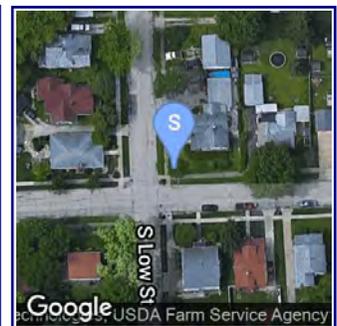
Address: 505 W miller st

Storm Inlet

Basin:
Segment (US : DS): **43970:43960**
Intensity: **Medium**
Drainage Area (SF): **100**
Surface: **Paved**
Comments:

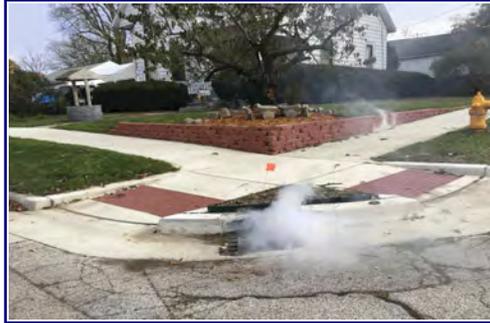
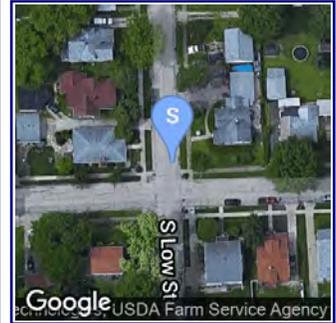
Address: 605 W miller st

Basin:
Segment (US : DS): **43980:43970**
Intensity: **High**
Drainage Area (SF): **1,000**
Surface: **Paved**
Comments:

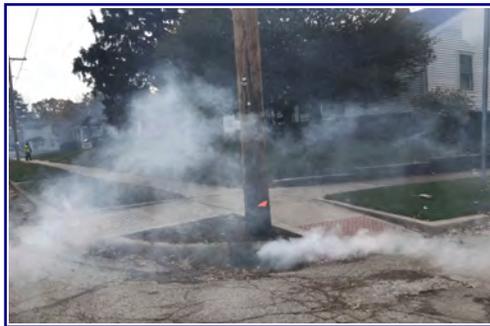
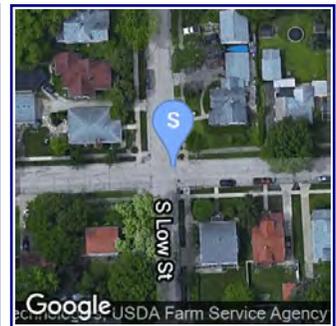
Address: 610 W miller st

Storm Inlet

Basin:
Segment (US : DS): **43980:43970**
Intensity: **High**
Drainage Area (SF): **1,000**
Surface: **Paved**
Comments:

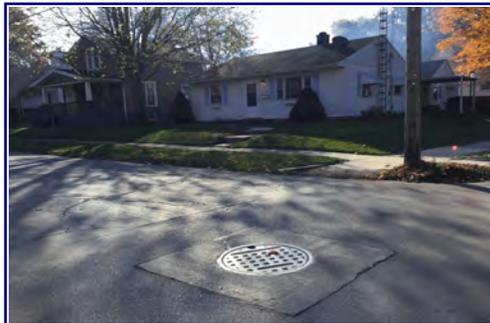
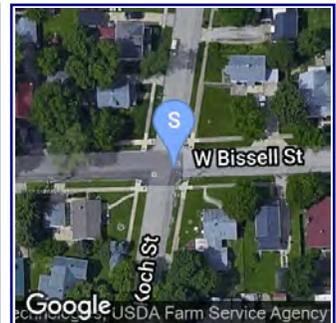
Address: 1220 Koch st

Storm Manhole

Basin:
Segment (US : DS): **43510:43500**
Intensity: **Low**
Drainage Area (SF): **1,000**
Surface: **Paved**
Comments:

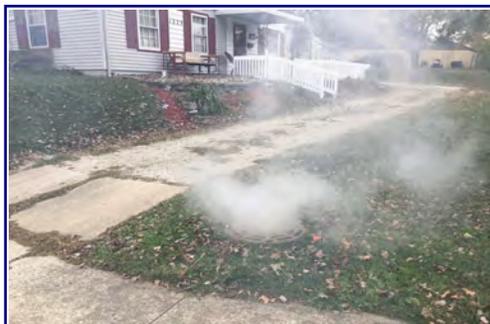
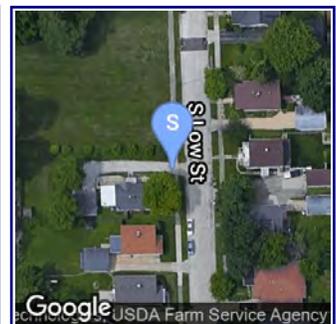
Address: 1223 Low St

Storm Manhole

Basin:
Segment (US : DS): **44090:43450**
Intensity: **High**
Drainage Area (SF): **1,000**
Surface: **Unpaved**
Comments:

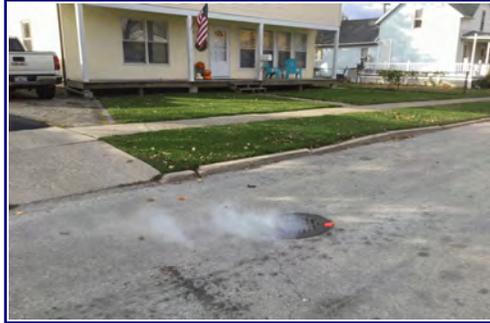
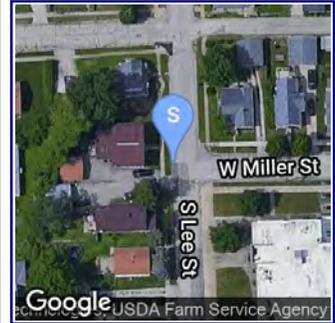
Address: 1203 S Lee St

Basin:
Segment (US : DS): **UNKNOWN:44270**
Intensity: **Medium**
Drainage Area (SF): **1,000**
Surface: **Paved**
Comments:

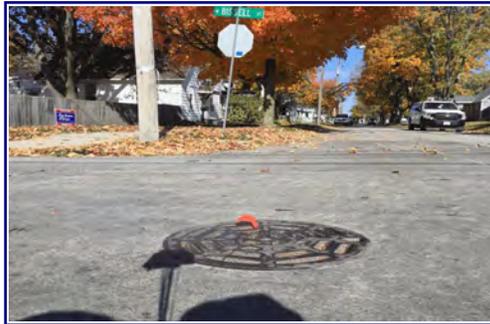
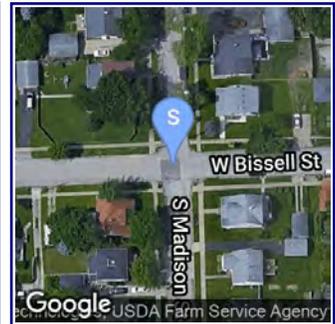
Address: 1301 S madiso st

Storm Manhole

Basin:
Segment (US : DS): **43510 :43520**
Intensity: **Low**
Drainage Area (SF): **1,000**
Surface: **Paved**
Comments:

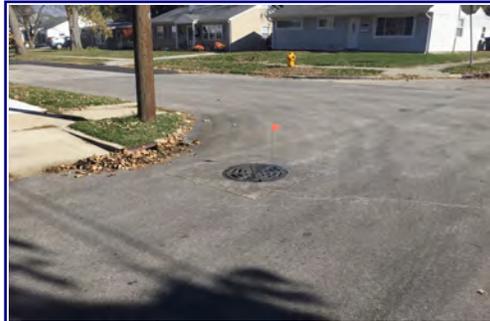
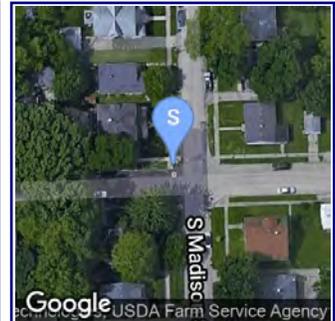
Address: 1401 S Madison St

Storm Manhole

Basin:
Segment (US : DS): **43520:43510**
Intensity: **Medium**
Drainage Area (SF): **1,000**
Surface: **Paved**
Comments:

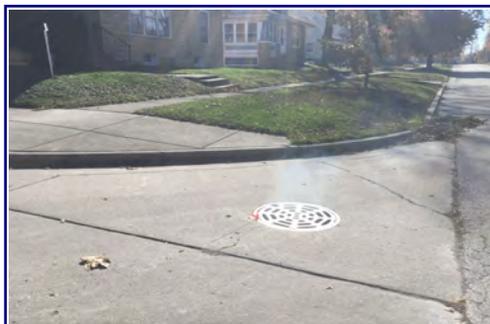
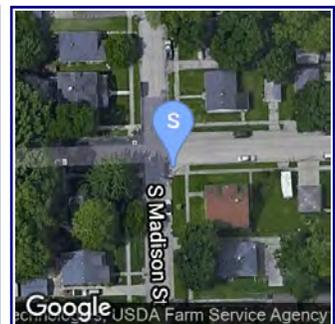
Address: 1402 S Madison St

Storm Manhole

Basin:
Segment (US : DS): **43520:43510**
Intensity: **Medium**
Drainage Area (SF): **1,000**
Surface: **Paved**
Comments:
