**2020 SSES PROGRAM CITY
OF BLOOMINGTON, IL
FINAL REPORT**

MAY 2021

PROJECT NO: 11-3577-01

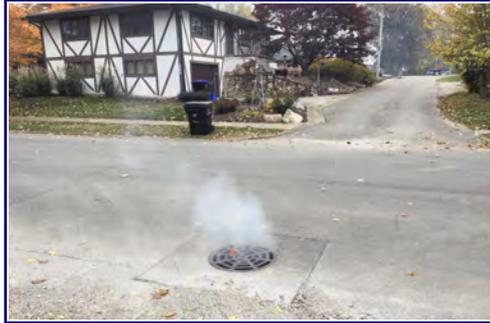
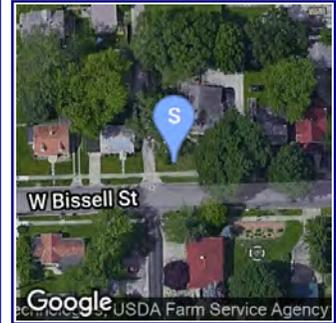
Address: 405 W Bissell St

Basin:
Segment (US : DS): **43500:43490**
Intensity: **High**
Drainage Area (SF): **1,000**
Surface: **Paved**
Comments:

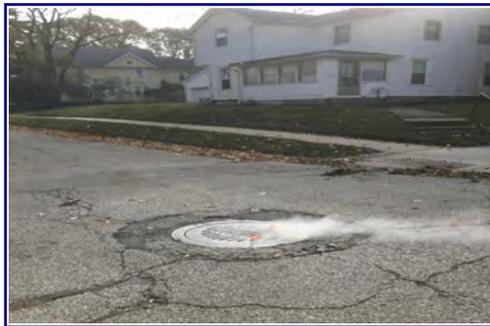
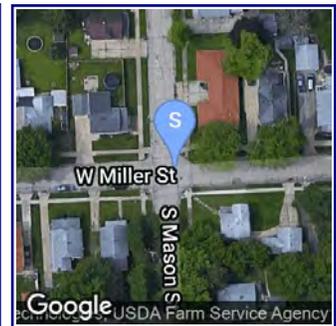
Address: 1202 W Miller St

Basin:
Segment (US : DS): **43990:43980**
Intensity: **High**
Drainage Area (SF): **500**
Surface: **Paved**
Comments:

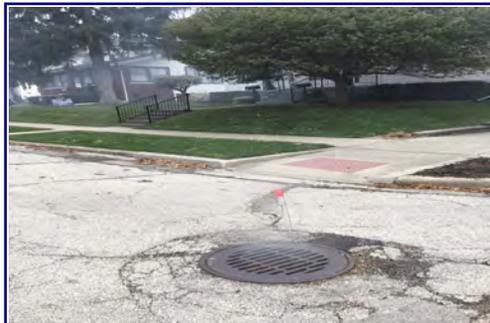
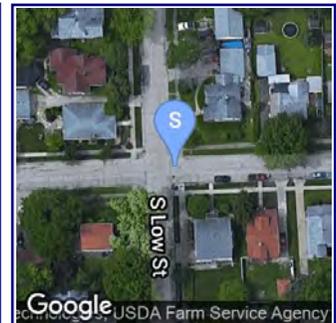
Address: 608 W Miller St

Storm Manhole

Basin:
Segment (US : DS): **43970:43960**
Intensity: **Medium**
Drainage Area (SF): **1,000**
Surface: **Paved**
Comments:

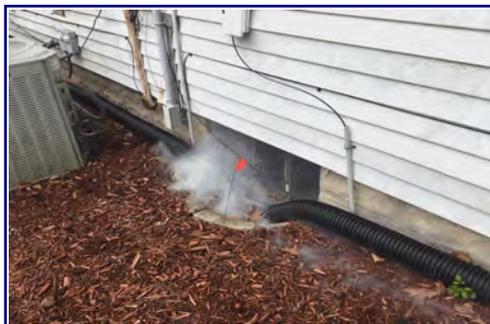
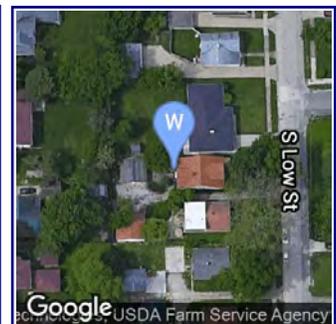
Address: 1403 Low St

Window Well Drain

Basin:
Segment (US : DS): **44100:44090**
Intensity: **High**
Drainage Area (SF): **500**
Surface: **Unpaved**
Comments:
