**AGENDA
HISTORIC PRESERVATION
CITY HALL COUNCIL CHAMBERS
109 EAST OLIVE STREET; BLOOMINGTON, IL 61701
THURSDAY, August 15, 2019 at 5:00 P.M.**

CASE NO:	TYPE:	ADDRESS	SUBJECT:	REPORT BY:
BHP-25-19	Certificate of Appropriateness	402 E. Grove	Window restoration and installation of storm windows, removal, repair, and replacement of section of clapboard siding, installation of insulation	Casey Weeks, Assistant City Planner
BHP-26-19	Funk Grant	402 E. Grove	Window restoration and installation of storm windows, removal, repair, and replacement of section of clapboard siding, installation of insulation	Casey Weeks, Assistant City Planner

CASE NO:	TYPE:	ADDRESS	SUBJECT:	REPORT BY:
BHP-27-19	Rust Grant	305 W. Monroe St.	Brick repointing	Casey Weeks, Assistant City Planner

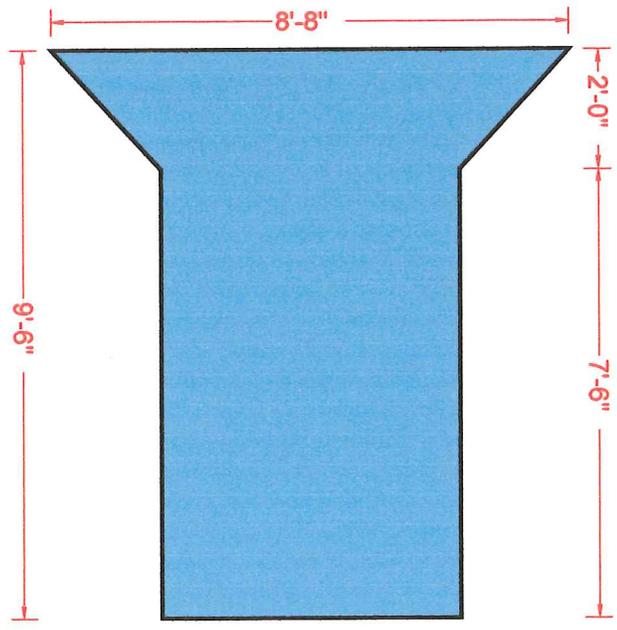
Front Sidewalk

Description	Total
Sidewalk replacement (front only) FRONT SIDEWALK Tear out and replace sidewalk as indicated on diagram. Will pour back as 4 inches of 4000 PSI concrete with fiber and wire mesh reinforcement, with a recycled gravel base below grade. Expansion and control joints will be placed as needed. New concrete will receive a light broom finish. A penetrating sealer will be sprayed to prevent corrosion.	995.00
Total \$995.00

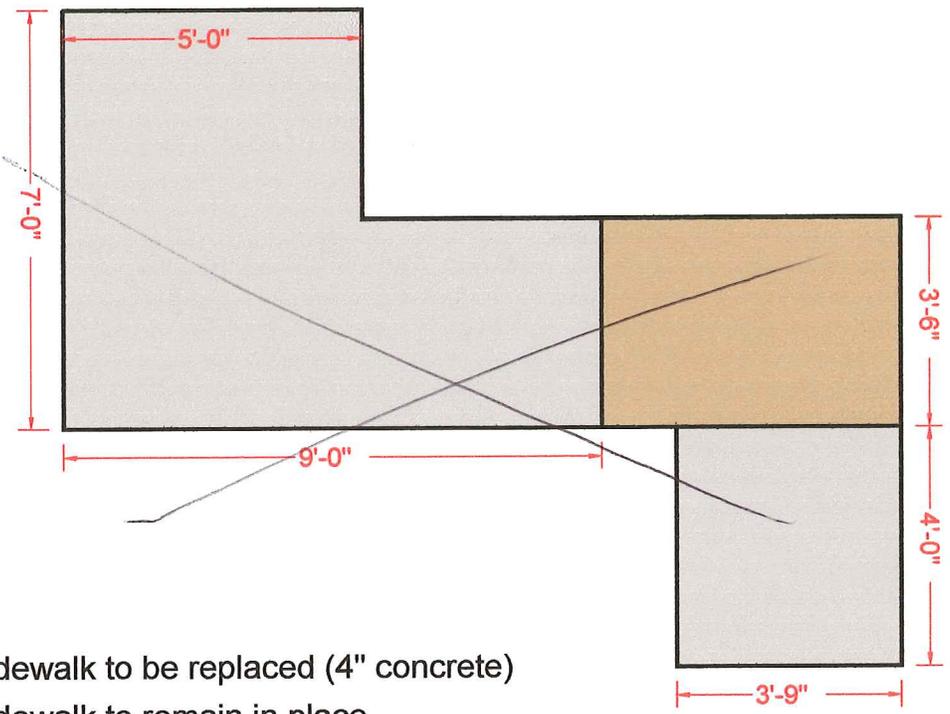
Back Sidewalk
Not included

- Sidewalk to be replaced (4" concrete)
- Sidewalk to remain in place
- Optional sidewalk to be replaced (4" concrete)

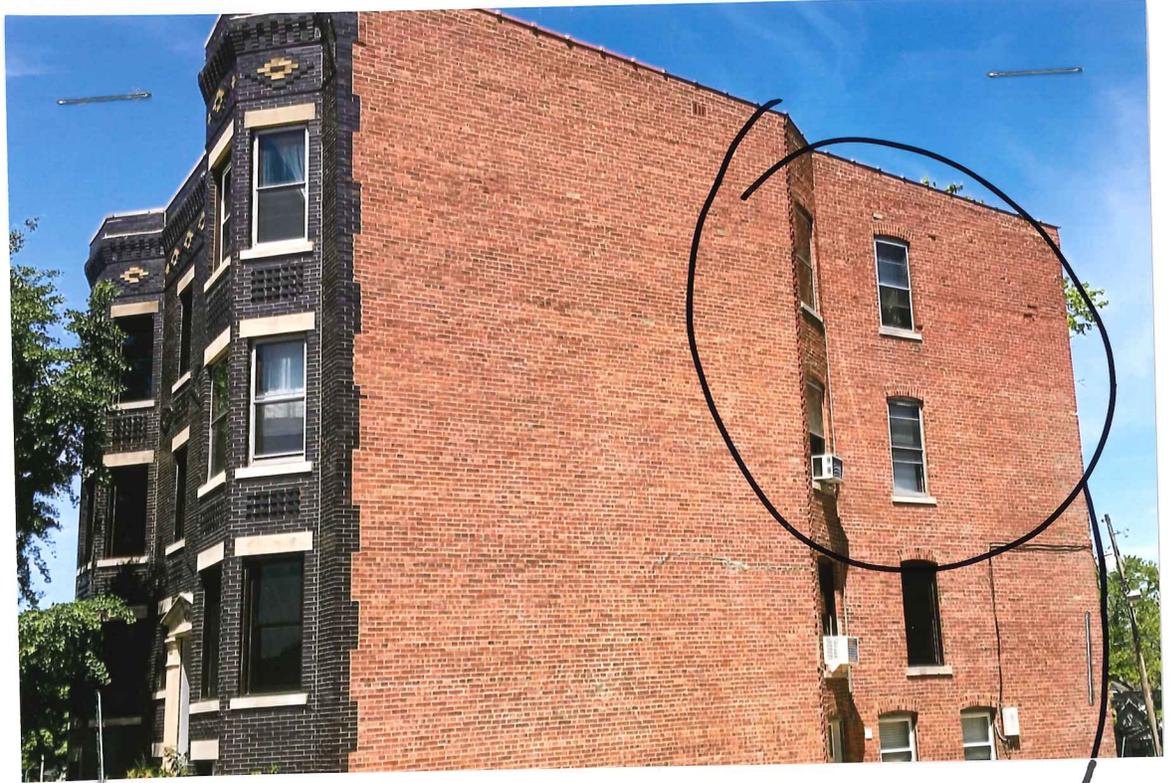
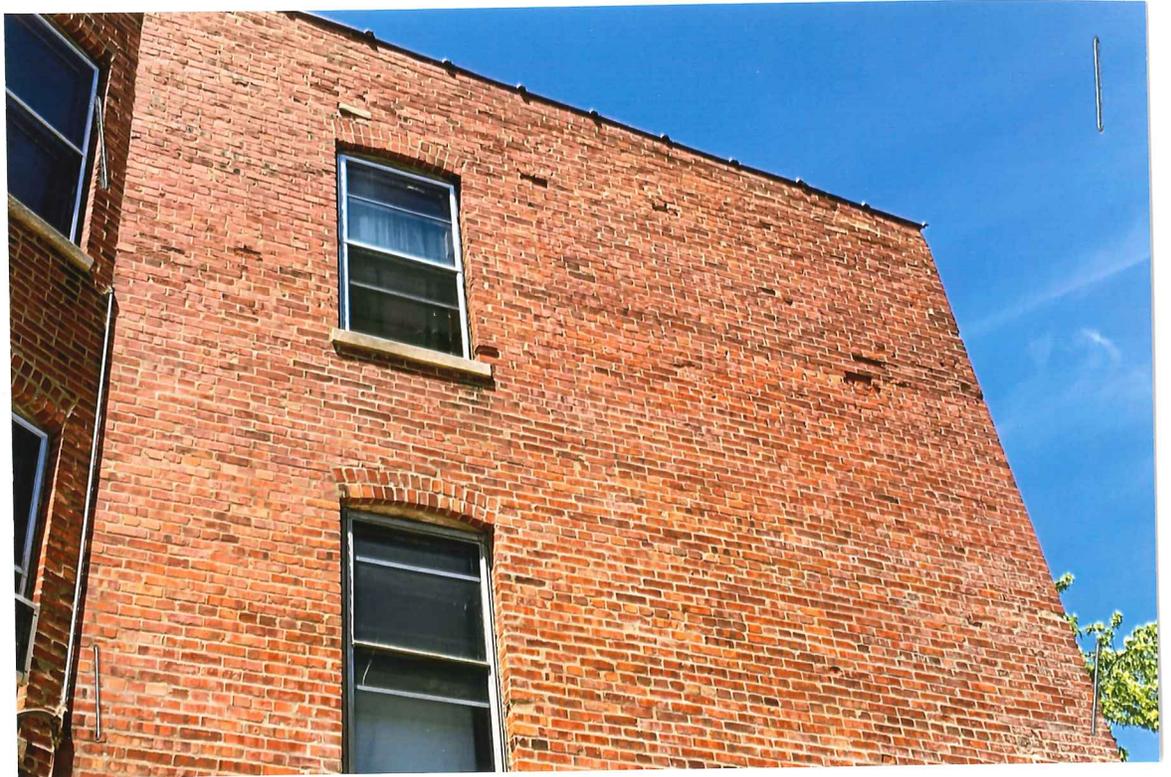
East
side of
building.

Note missing
or broken
bricks

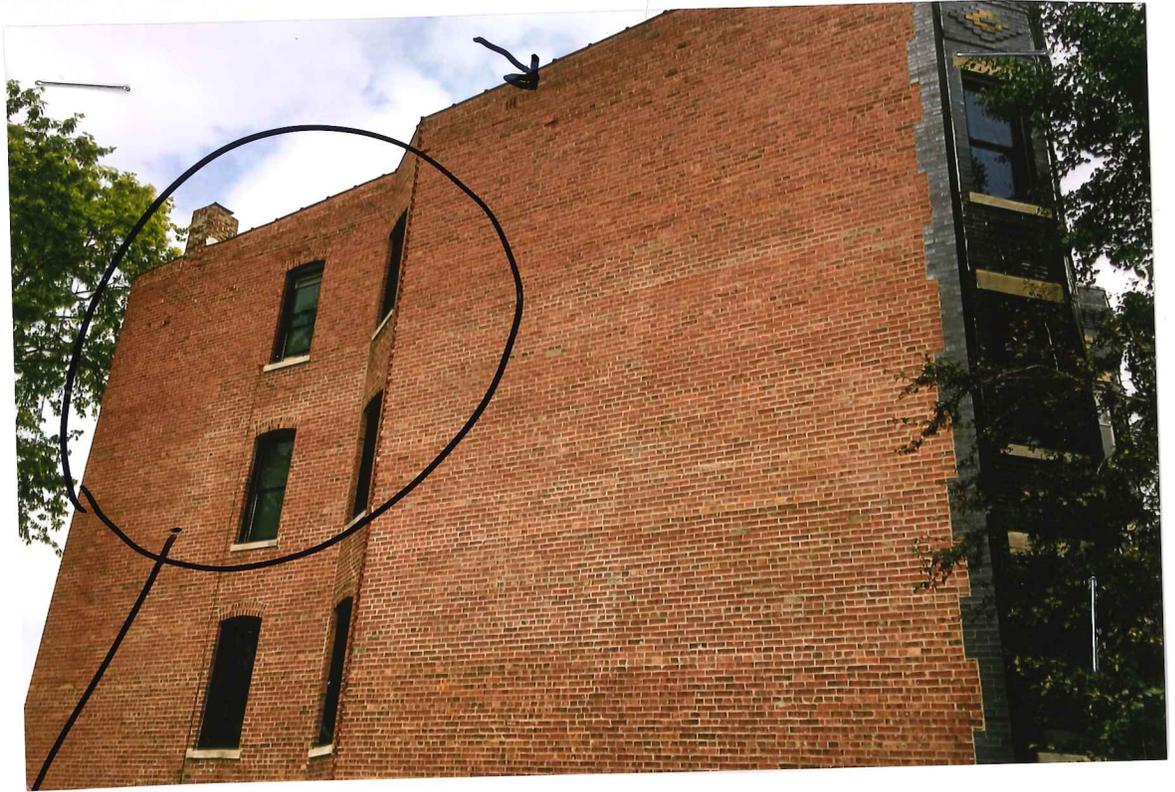
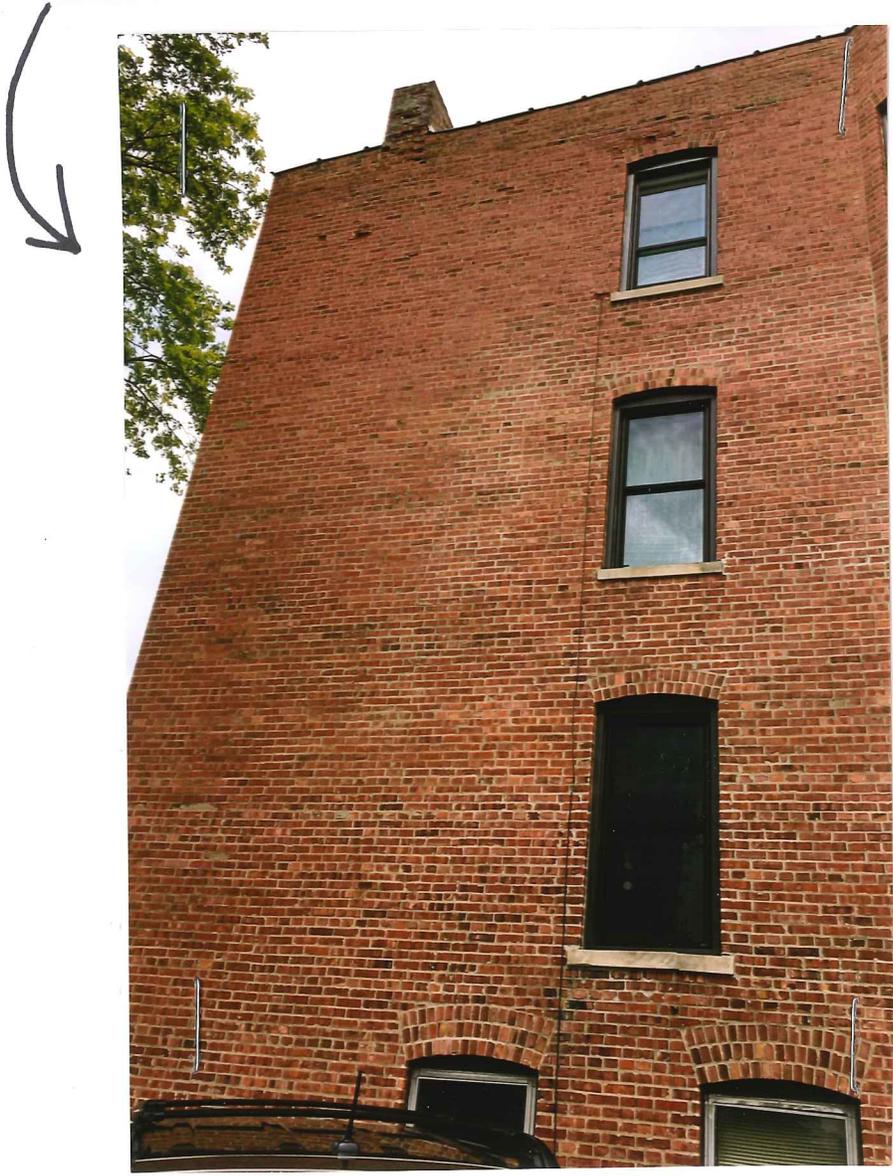
West
Side of
building.

Note missing
or broken
bricks.

Note chimney.

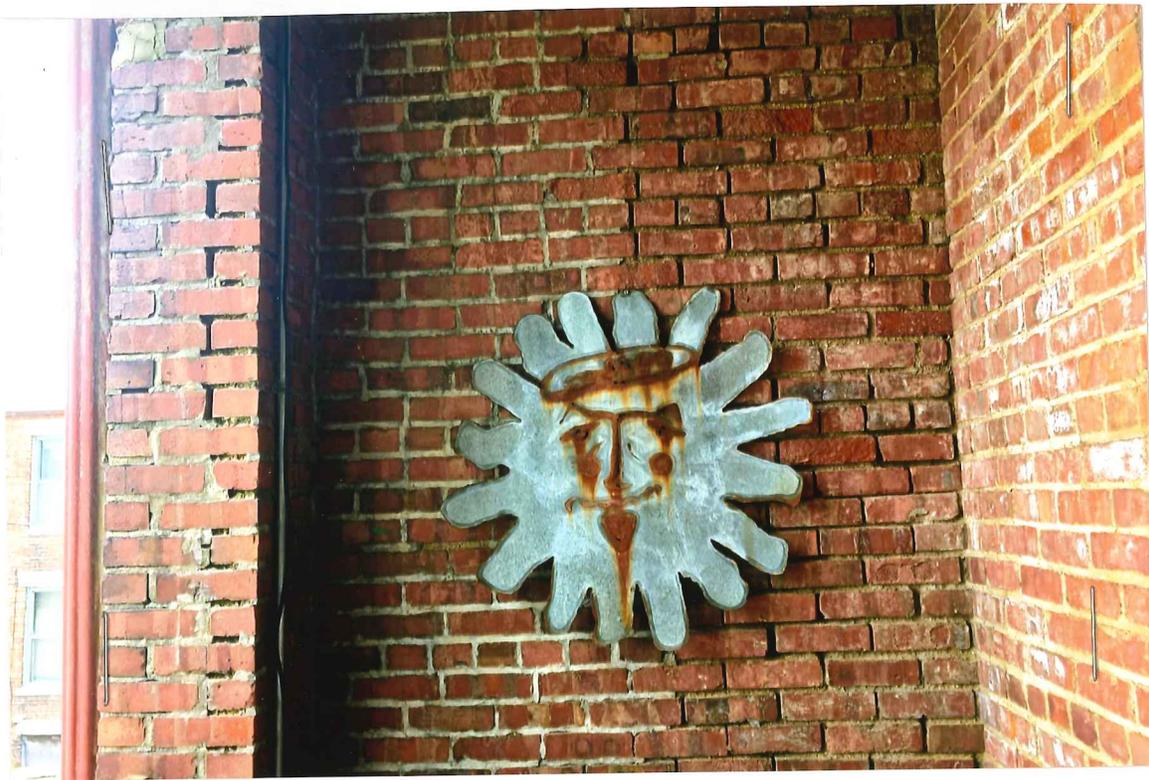
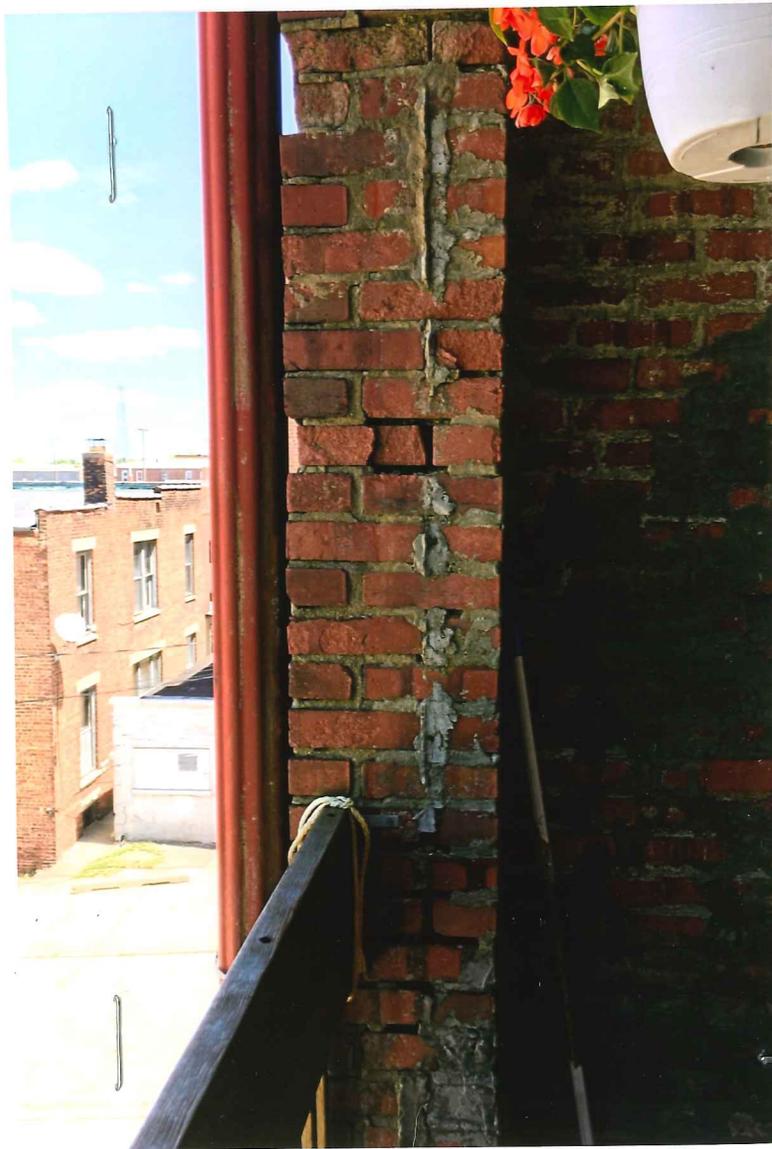
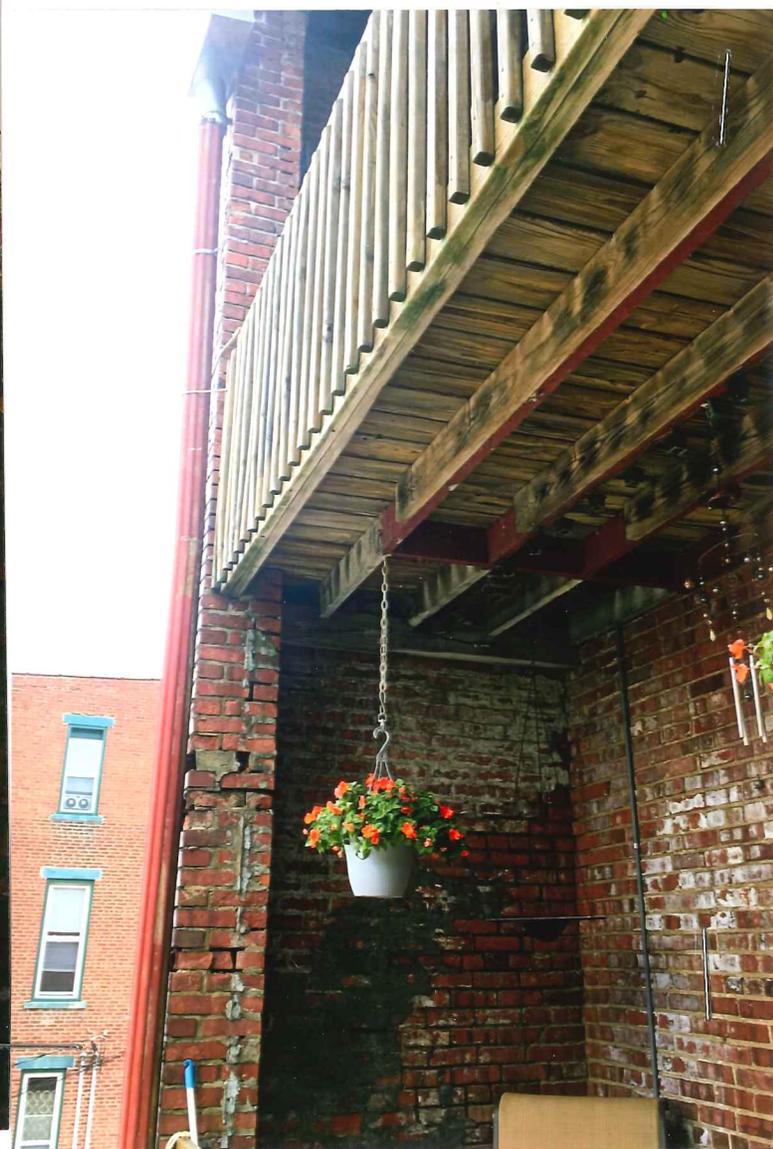
South
side
of
building
Note
missing
brick
and
broken
mortar.

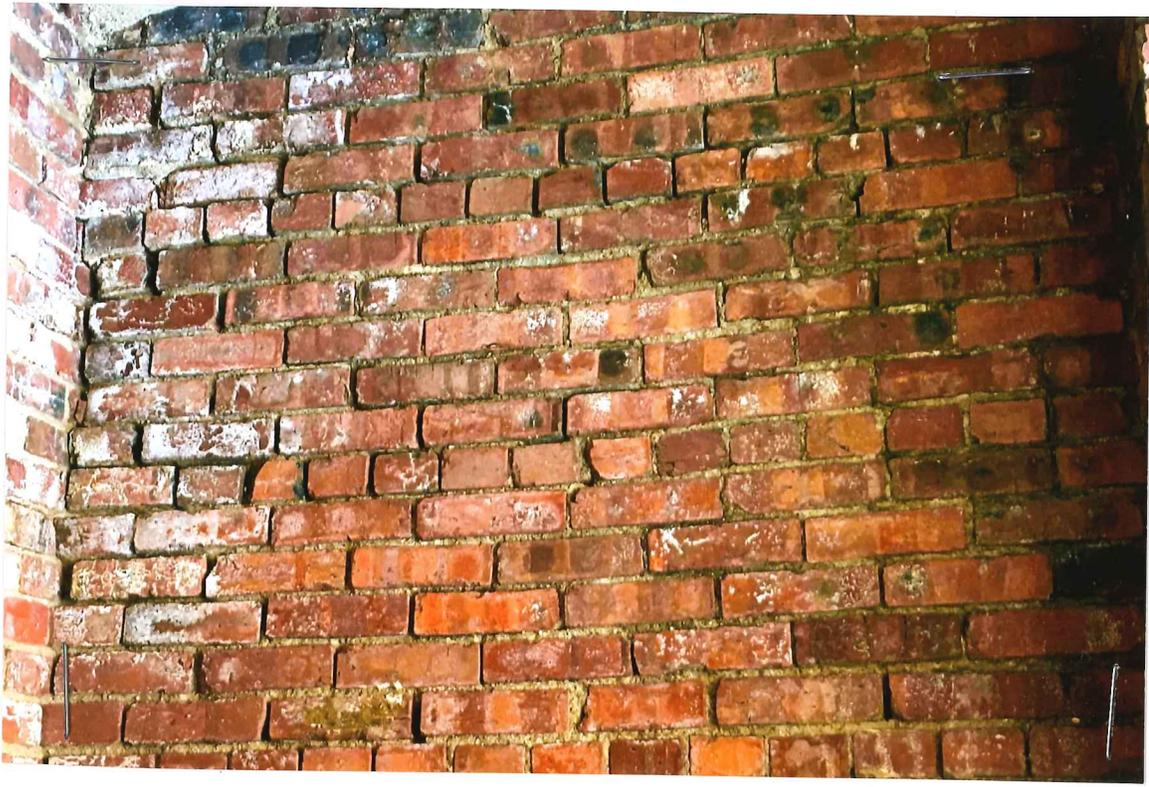
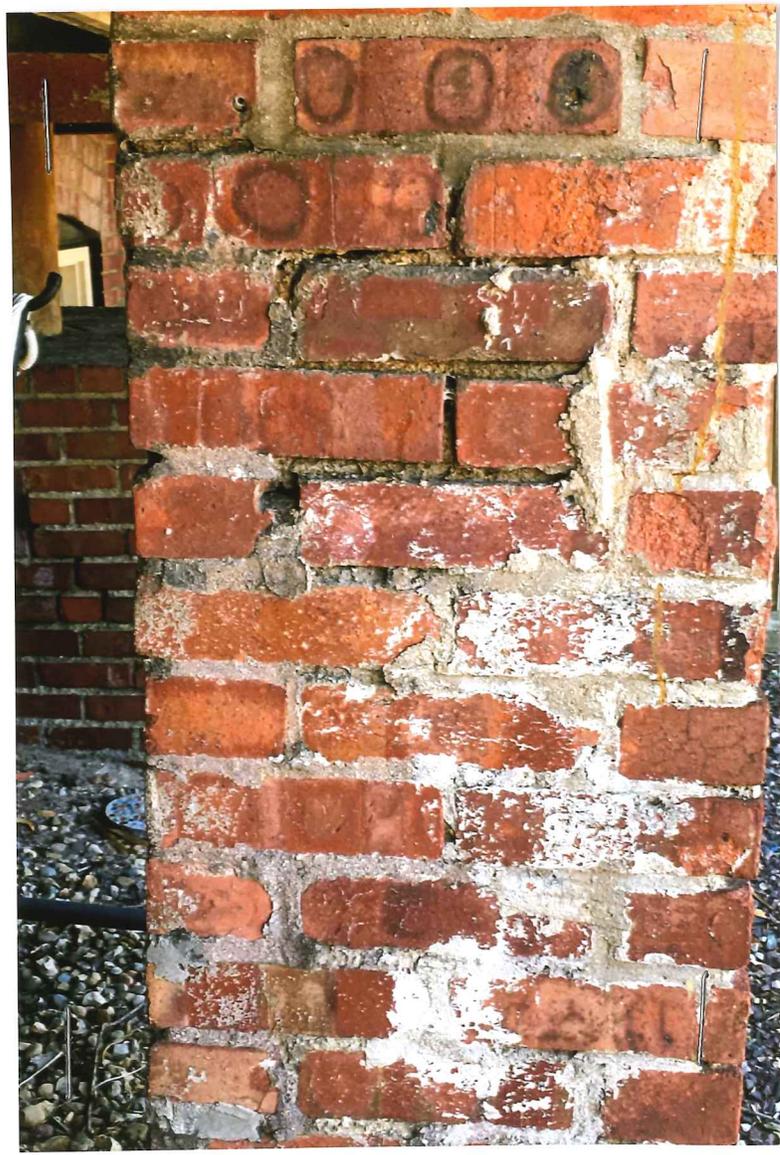
South
side
of
building
Bricks
surround
exterior
balconies.

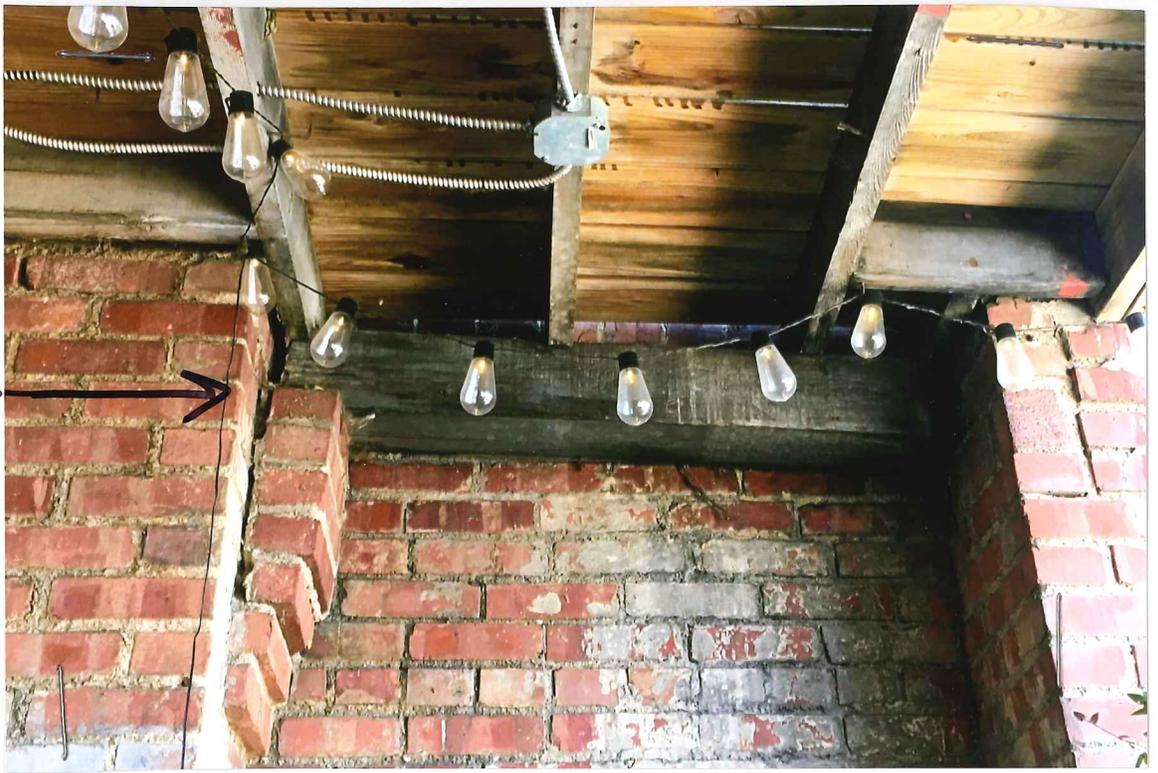
South side
of building

Bricks are
supporting
beam for
exterior
balconies.
